PHYSICAL PROCESSES, HUMAN IMPACTS, AND RESTORATION ISSUES OF THE LOWER DUNGENESS RIVER

Clallam County, Washington

**Prepared for Jamestown S’Klallam Tribe
by the
U.S. Department of the Interior
Bureau of Reclamation
May 2002**

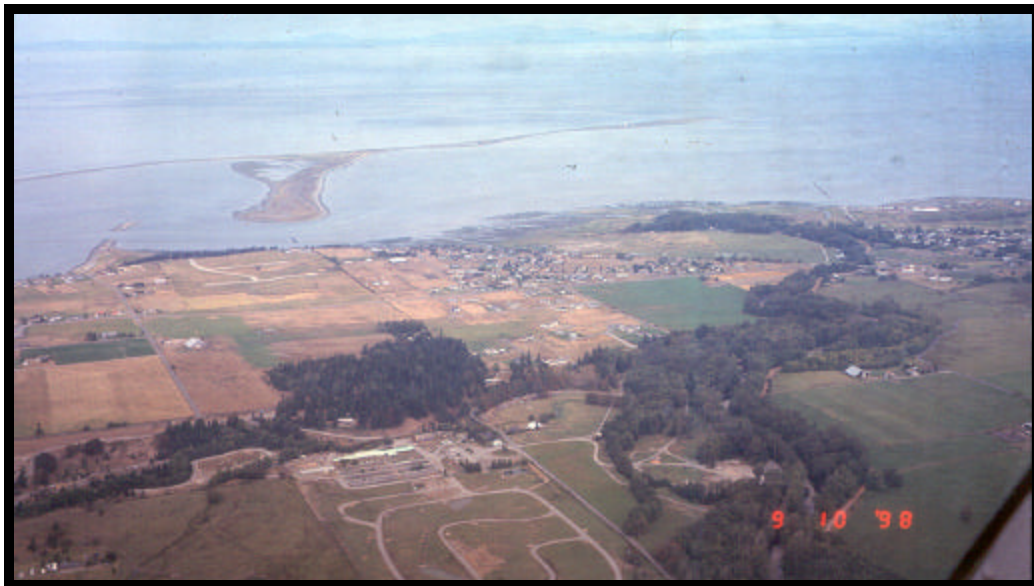
Photo 2: The Dungeness River flows north for about 32 miles from the mountains into Dungeness Bay. The Dungeness Spit separates Dungeness Bay from the Strait of Juan de Fuca. The spit is formed by long shore drift currents in the Strait. Photo taken 9-10-98.

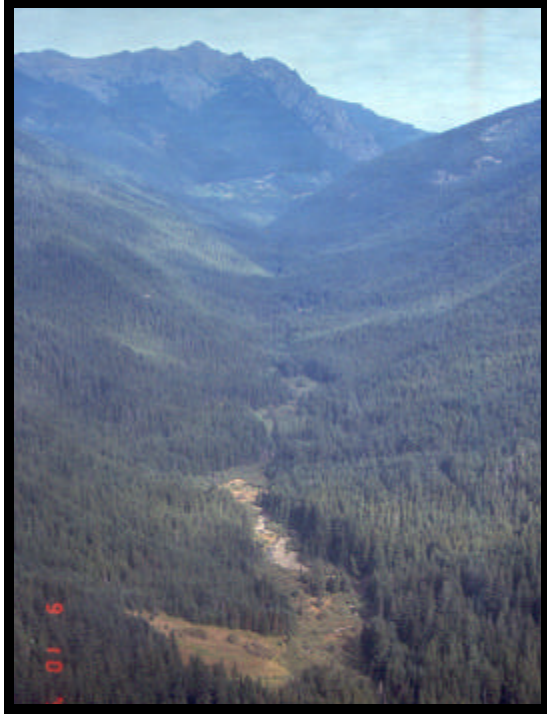
Photo 3: In the upper Dungeness River watershed, the channel slope becomes steeper with elevation. At lower elevations where the channel is less steep, a narrow floodplain is evident. The majority of the upper watershed is heavily forested.

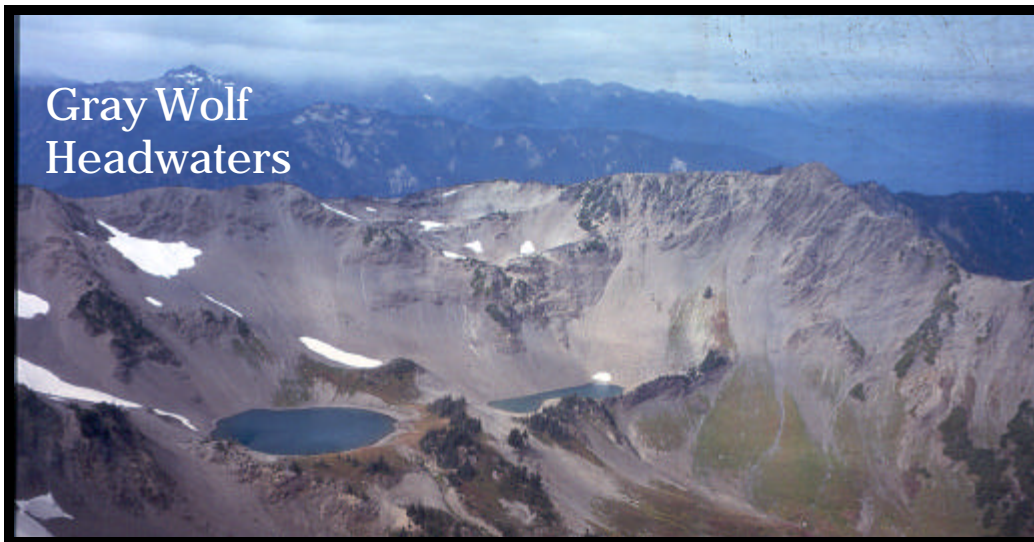
Photo 4: The Gray Wolf is the largest tributary to the Dungeness River. The high elevations of the Gray Wolf drainage are above timberline. Photo taken 9-10-98.

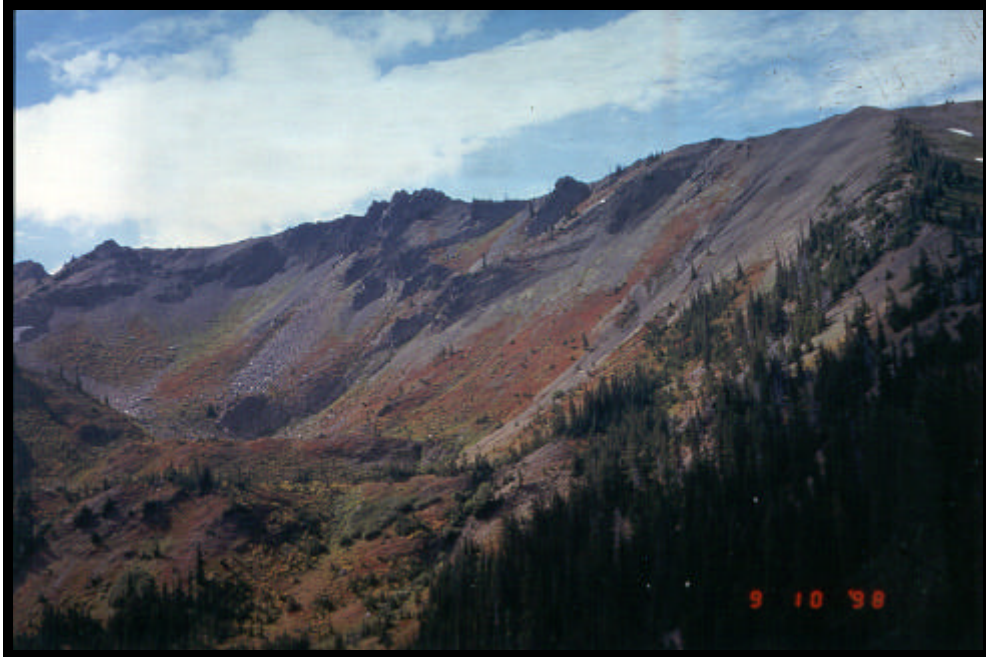
Photo 5: Large quantities of sediment were observed to be stored along the high alpine slopes above timberline in the Gray Wolf watershed. Photo taken 9-10-98.

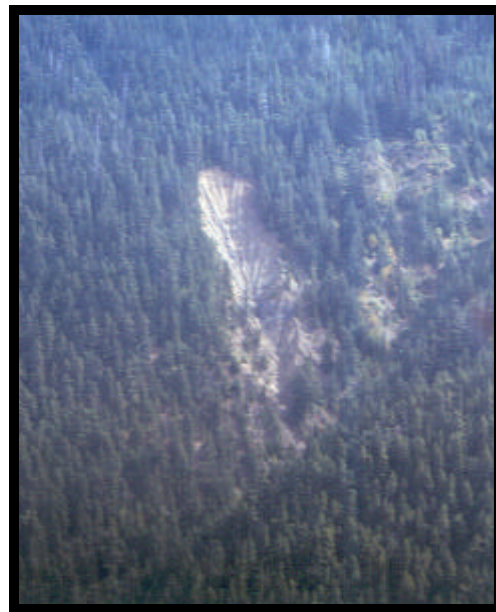
Photos 6A and 6B: Landslides are part of the natural process in the Dungeness watershed. However, in many areas of the watershed logging practices may initiate or reactivate landslides that would otherwise not occur. The landslides contribute fine sediment (silt and clay) to the river channel, but the percentage of coarse sediment (sand and gravel) is likely small. Photos taken 9-10-98.

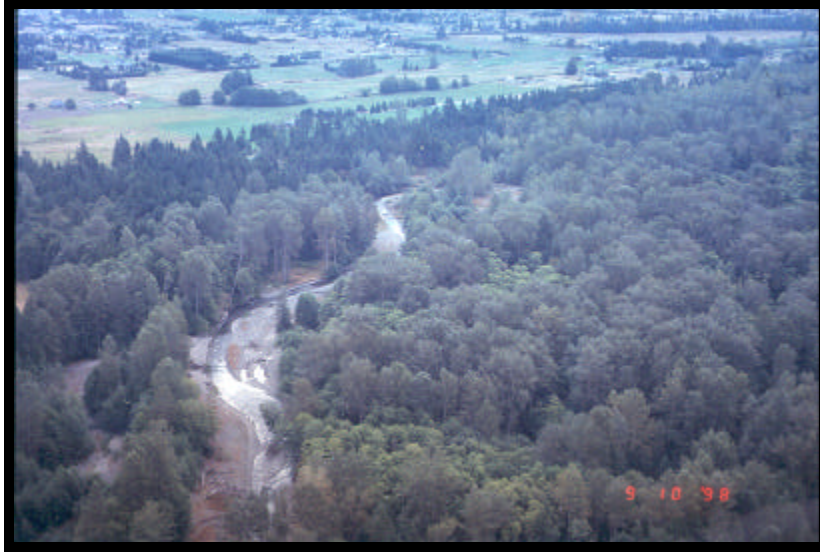
Photo 7: In the lower 10.5 miles of the Dungeness River, the main river channel passes through a forested floodplain. The forested floodplain often contains smaller side and overflow channels which are not readily visible from the air. The river is dynamic and can migrate over time throughout the forested floodplain. Photo taken 9-10-98.

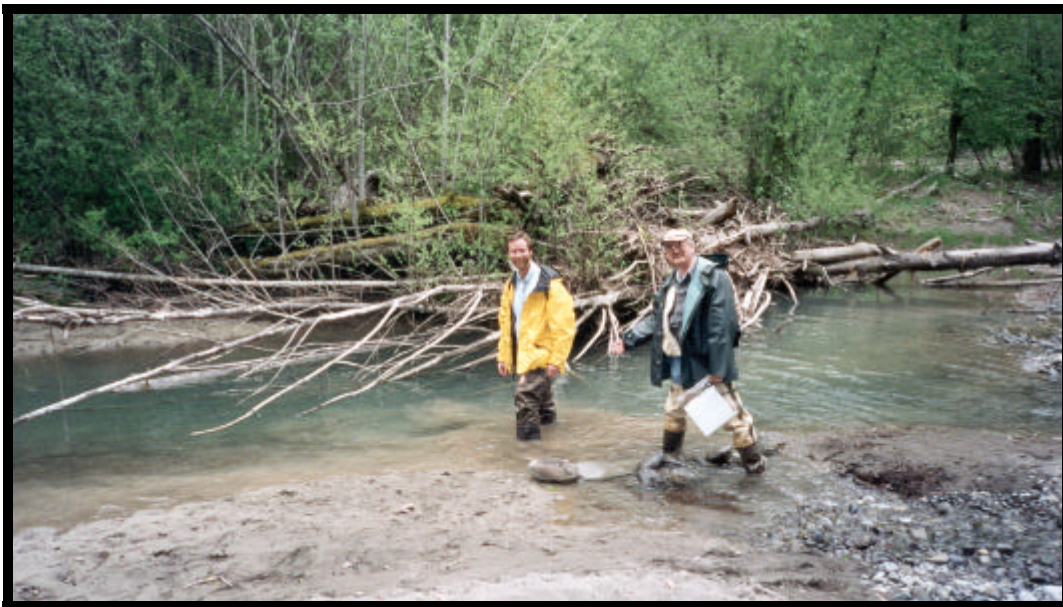
Photo 8: Side channels in the forested floodplain such as this one can provide important fish habitat. Log jams often exist at the upstream entrance to these side channels. The log jams limit the flow velocity and coarse sediment entering the side channel which in turn leads to stability of the side channel and fish habitat. Photo taken 5-18-99.

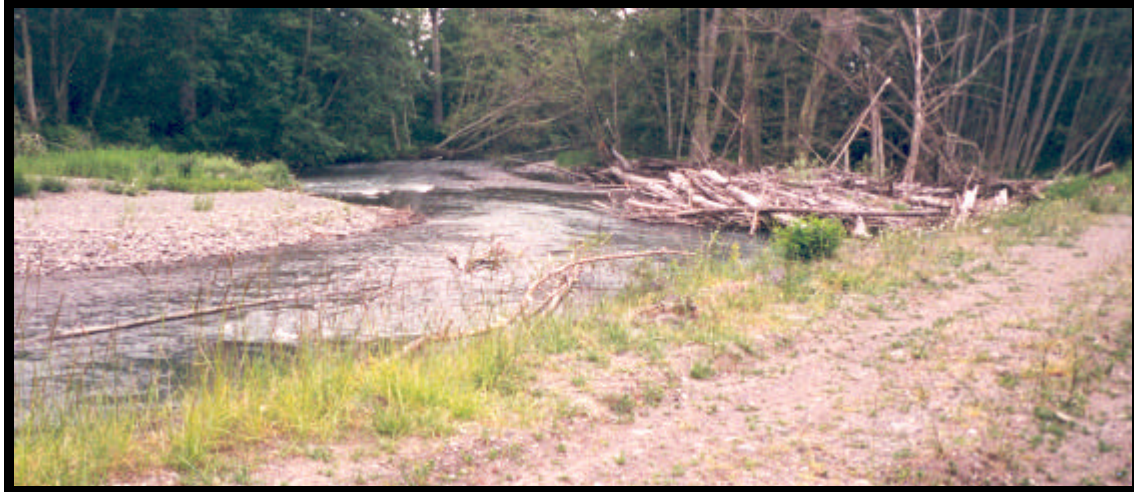
Photo 9: Where log jams do exist in the main channel, they form stable scour pools as flow accelerates around the wood. These scour pools provide excellent fish habitat and are a natural part of physical processes on the Dungeness River. Removal of log jams from the channel has reduced the number of log jams and pools present in the river today. The construction of levees increases water depth and velocity and the river's capacity to transport wood through the system. Photo taken 6-28-01.

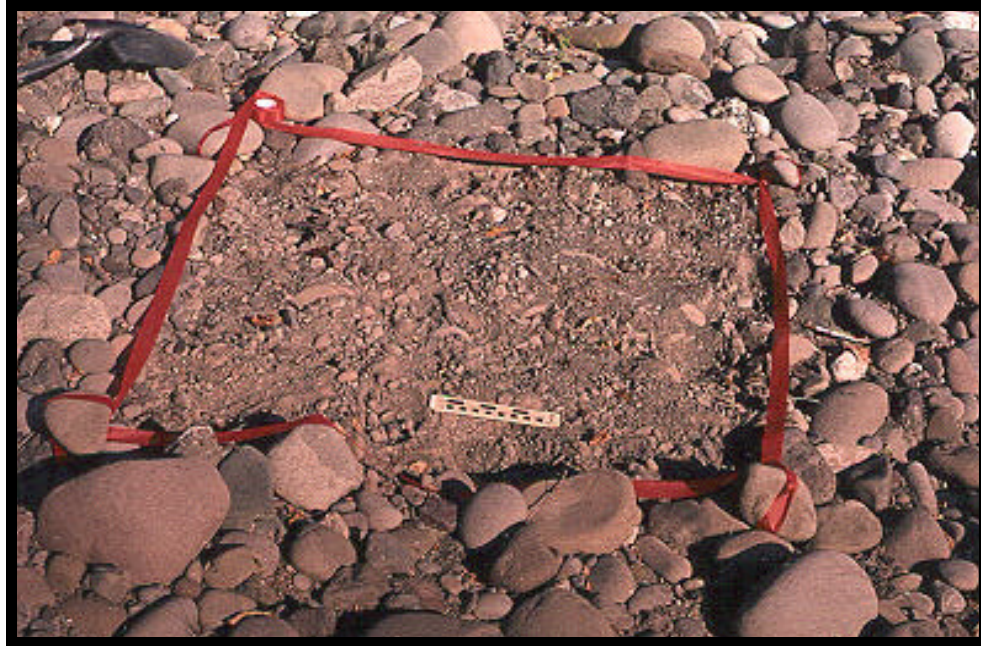
Photo 11: Bed-material samples in gravel bars were taken in 3-ft (1-m) squares to determine the sizes of sediment present in the river channel. Analysis of the samples showed that the channel bed of the Dungeness River is typically composed of sand, gravel, and cobble-sized material. The sand-sized particles are typically present beneath a pavement layer of cobbles. In general, the size of the bed-material decreases in the downstream direction. Photo taken 9-9-98.

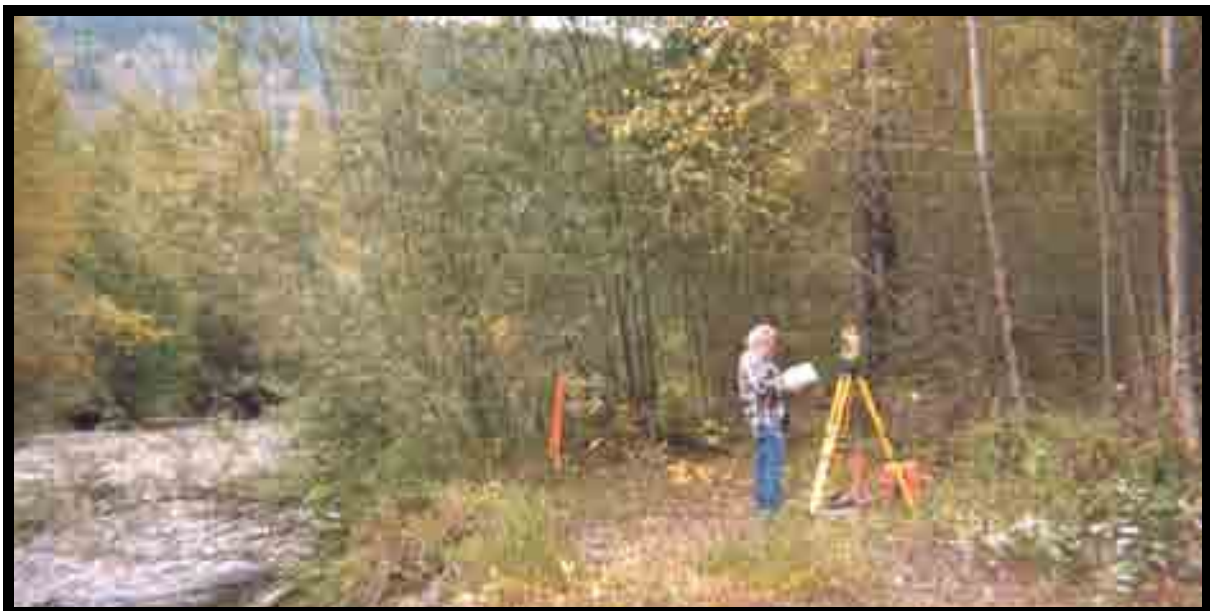
Photo 12: A permanent network of 60 cross sections was established in 1997 to monitor channel change over time. Past survey work was also used for comparison where possible. For example, between 1997 and 1999 the channel upstream from the Railroad Bridge (RM 5.5) straightened its course and eroded 5 ft of the channel bed. Deposition of a similar amount was observed downstream of the Railroad Bridge. Photo taken 10-98.

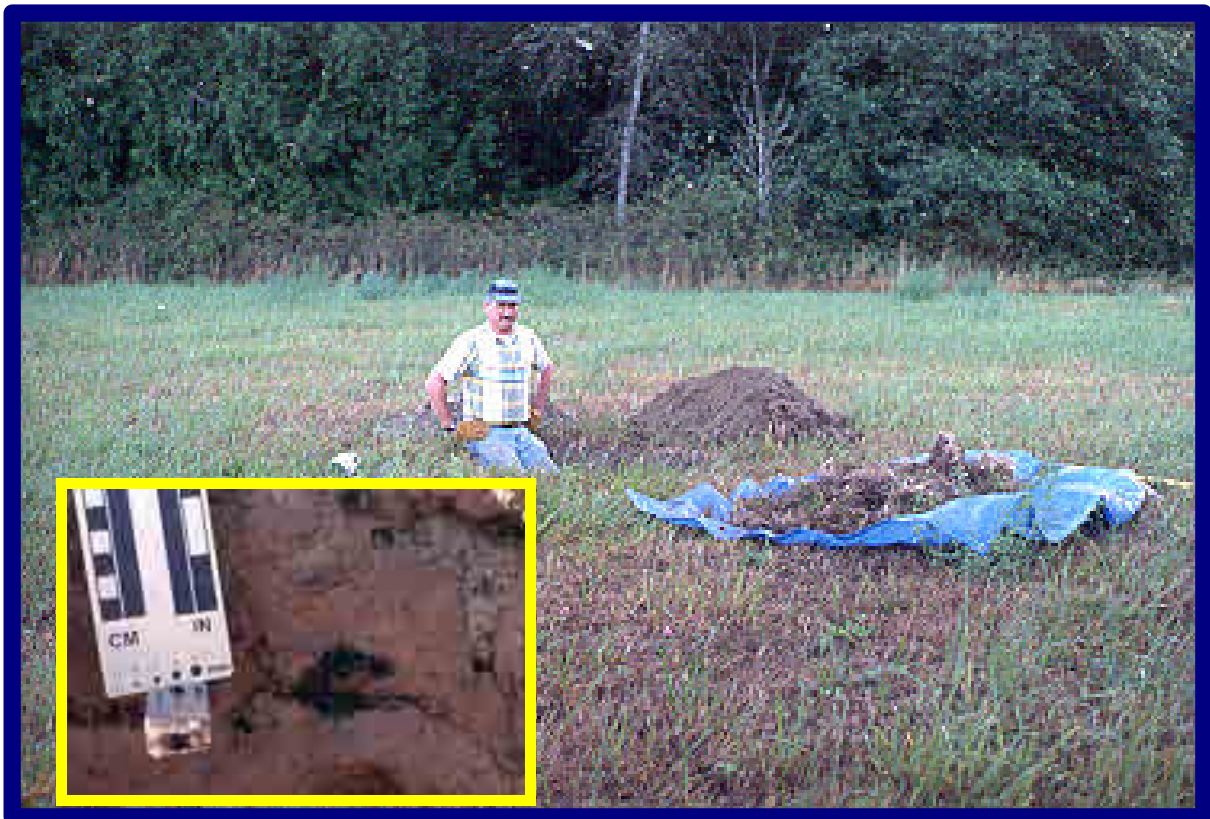
Photo 13: Natural exposures were excavated and used describe soil development. Where present, charcoal was collected and analyzed by radiocarbon dating. These dates along with soil development and geologic mapping helped identify the ages of terraces along the Dungeness River and establish the natural boundaries of the active river channel over the last several thousand years. Photo taken 9-13-98.

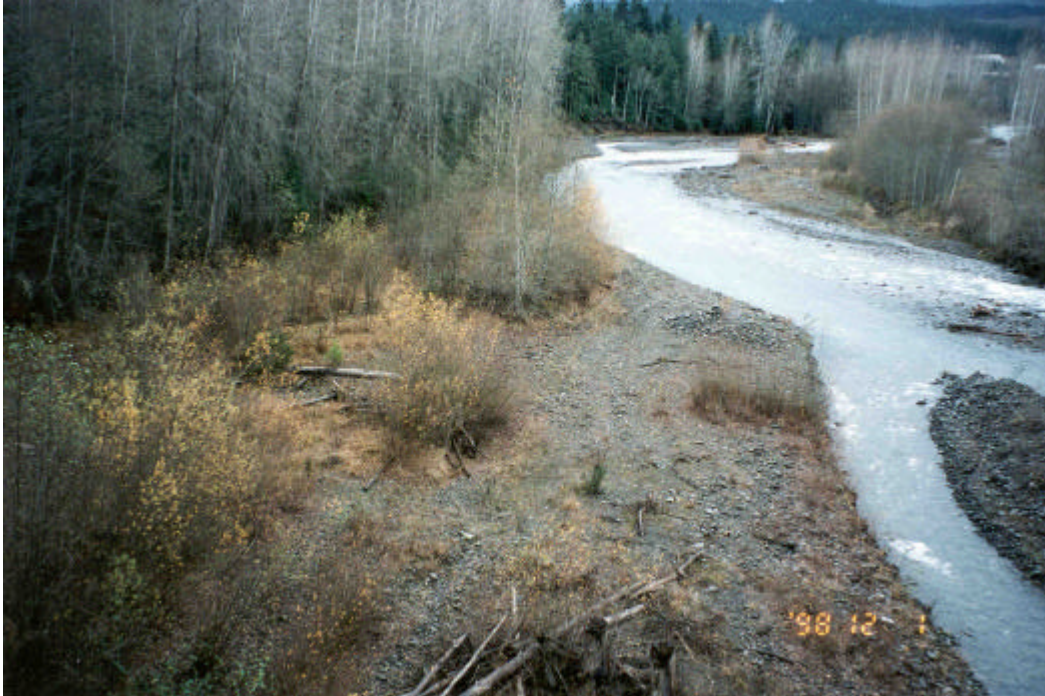
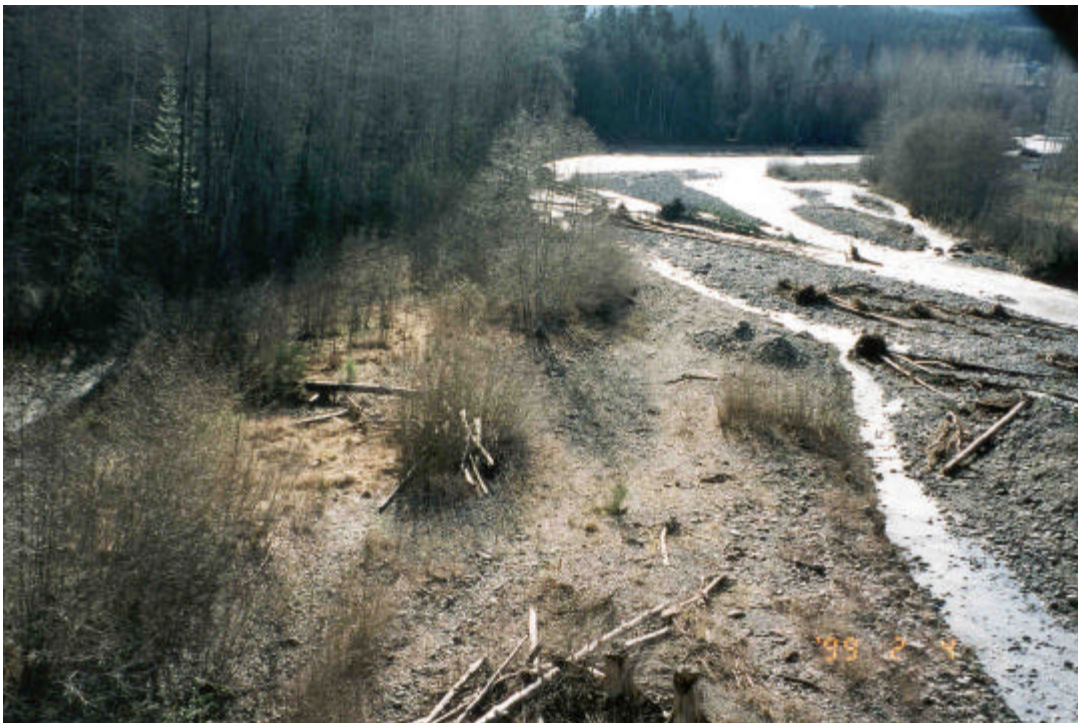
Photo 14A and 14B: At this location near RM 8.5 , time-lapse photography during the 1998-99 winter revealed a strong interaction between large woody debris and the formation of gravel bars. In Photo 14A the channel is relatively free of large woody debris of mid-channel gravel bars. In Photo 14B after the winter flood season, several winter floods deposited large woody debris and mid-channel gravel bars. Gravel bar deposition accelerated following the initial deposit of woody debris.

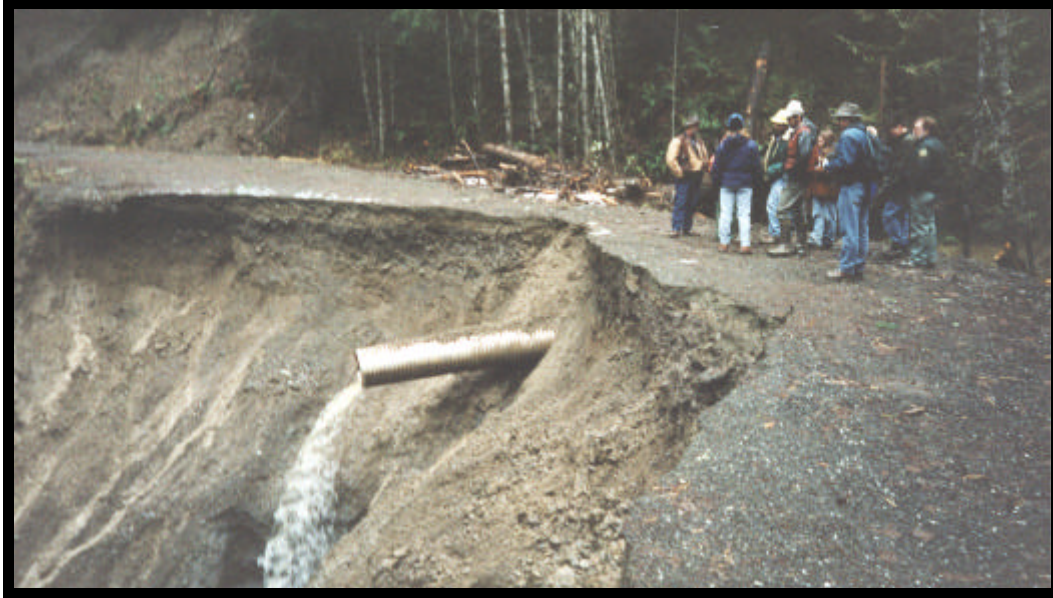
Photo 15: Numerous human impacts have affected the Dungeness River throughout the watershed. Several logging roads have been constructed in the upper watershed. Rainfall runoff can concentrate where a drainage crosses these logging roads. This concentrated flow can accelerate erosion processes including landslides such as shown here. These types of landslides can be a significant source of fine (silt and clay) sediment to the river channel. While these sizes of sediment do not cause channel change, they can increase turbidity in the river channel affecting fish feeding and spawning. Photo taken 5-17-00.

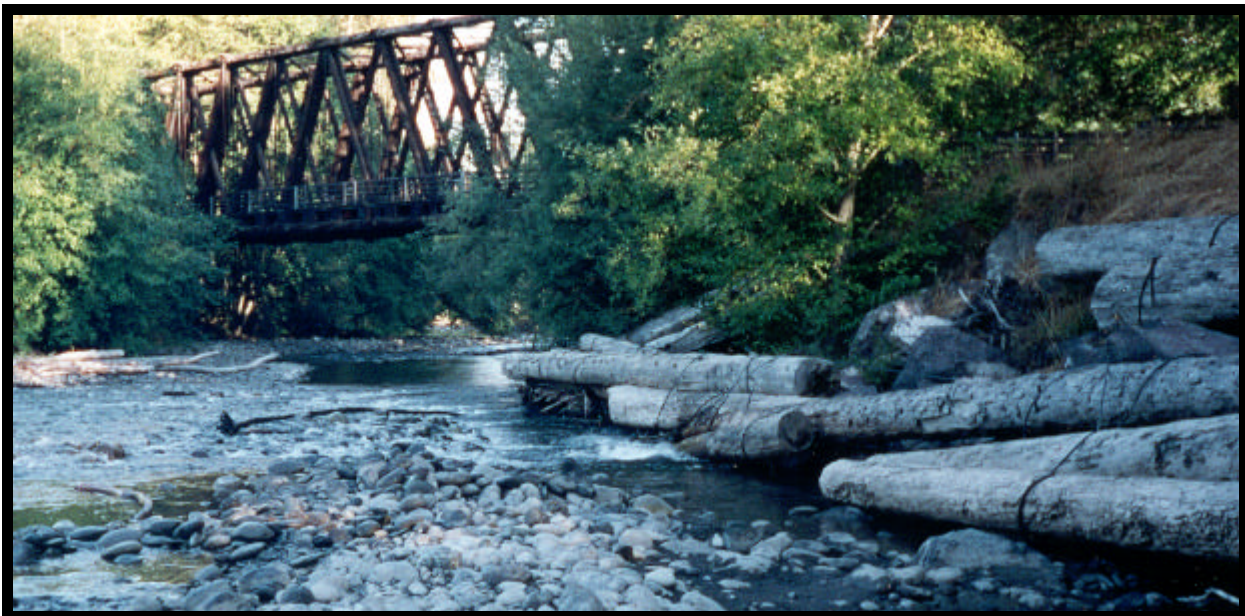
Photos 16: Five bridges cross the lower Dungeness River. The Railroad Bridge (RM 5.7) is heavily used for recreation and a newly developed River Center was built on the east side. A dike (built in 1961) and recently added cabled logs (visible at right) have been built to protect the new River Center. While the bridge does not constrict the active river channel, the dike does cut off the east floodplain.

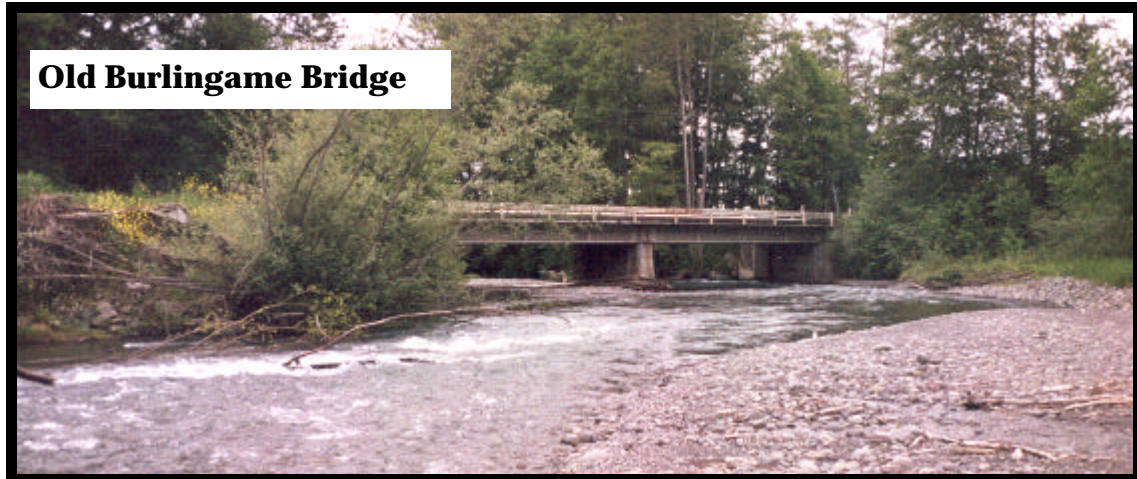
Photo 17: The Burlingame Bridge on Old Olympic Highway (RM 4) was replaced in 1998-99. The old bridge had a span of 130 ft which constricted the active river channel and cut off access to side channels and floodplain. Photo taken 5-21-98.

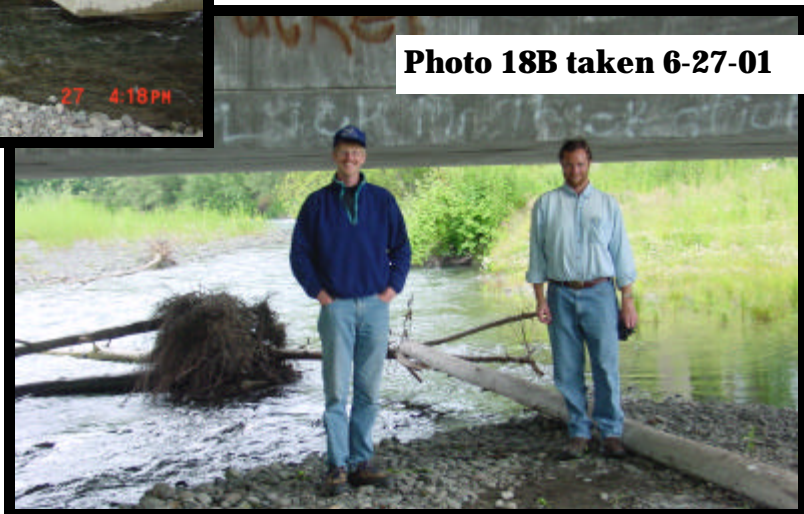
Photos 18A and 18B: The new Burlingame Bridge was built with an increased opening of 430 ft and no longer cuts off access to the wooded floodplain. During a recent site visit, woody debris and gravel bar deposition was observed under the bridge. Future changes in channel bed elevation and woody debris accumulation should be monitored to ensure the safety of the bridge.

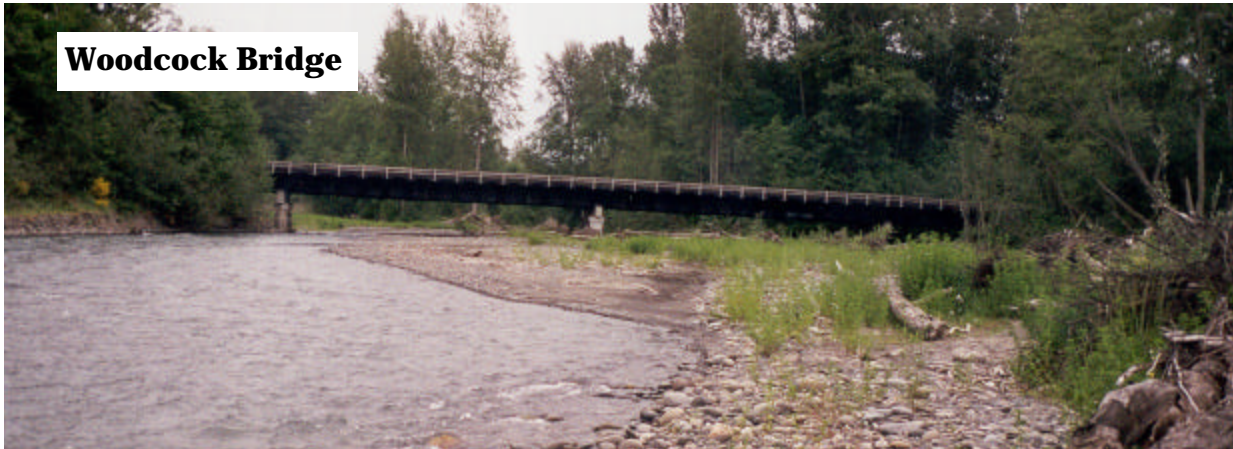
Photo 19: Woodcock Bridge, located at RM 3.3, has a span of 405 ft. This bridge cuts off access to the historic floodplain, constricts the channel migration zone, and causes sediment deposition upstream of the bridge. Photo taken 5-20-98.

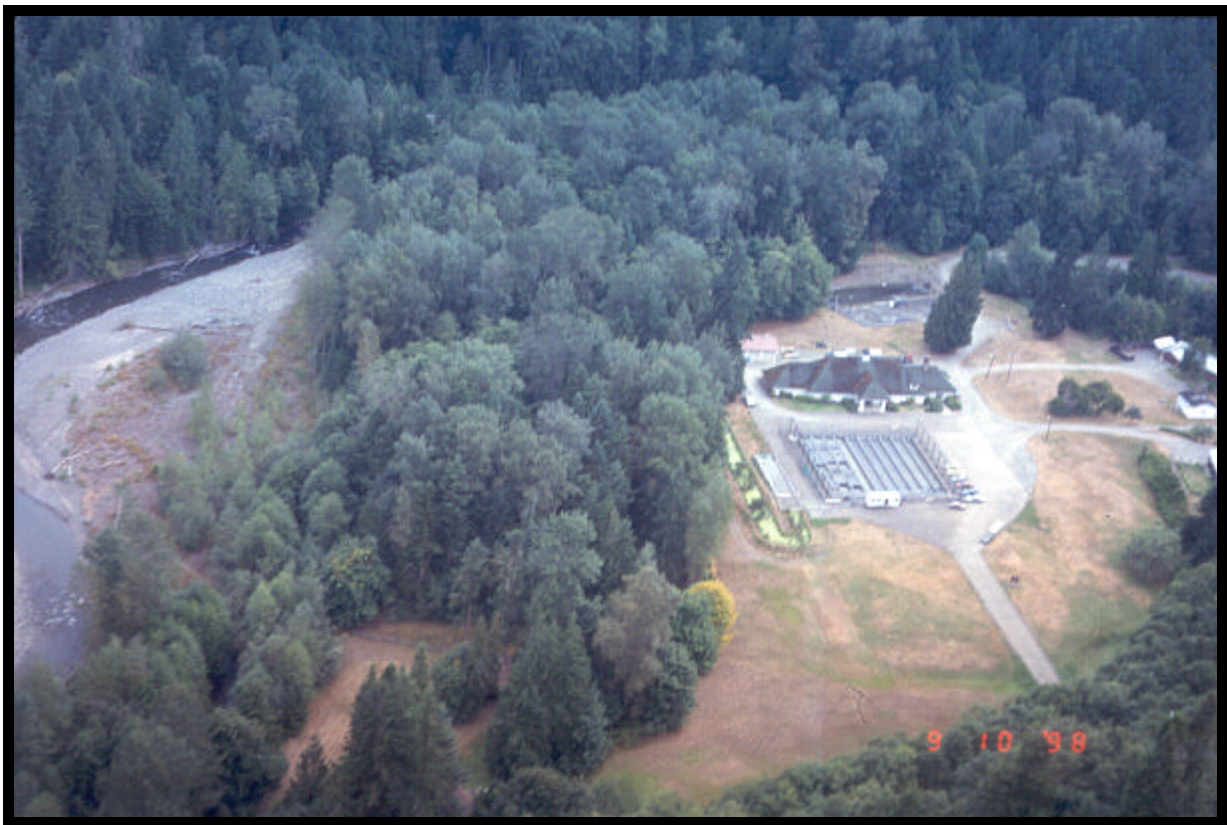
Photo 20: The fish hatchery is near the upstream end of the study reach (RM 10.5). Just upstream of the hatchery is the confluence with Canyon Creek, and just downstream of the hatchery is Kinkade Island & Creek. Photo taken 9-10-98.

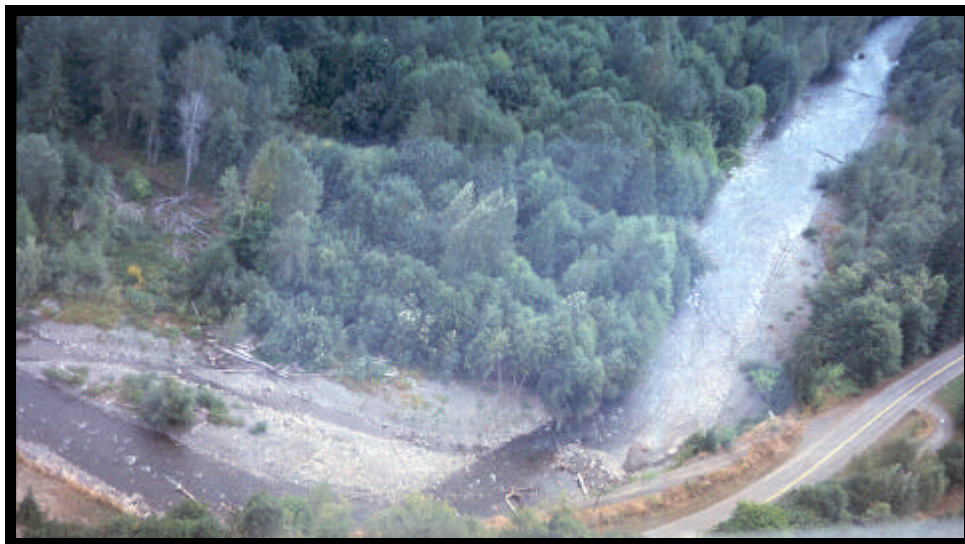
Photo 21: On the west side of Kinkade Island, the main channel has migrated to and eroded a portion of a high glacial deposit. This erosion forced Clallam County to setback the road. Further erosion was prevented by the placement of large angular boulders at the base of the slope. Photo taken 9-10-98.

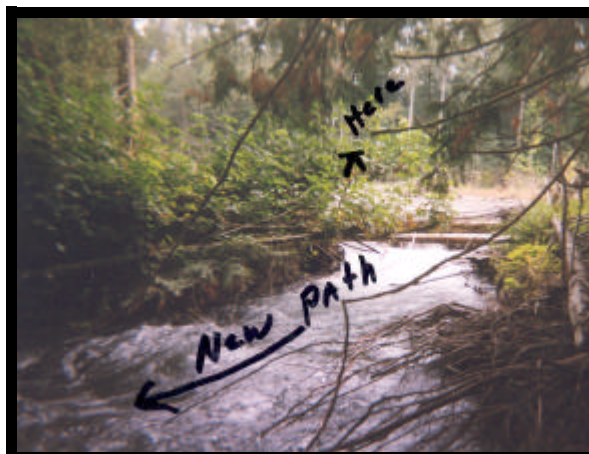
Photo 22A: Looking upstream at new entrance to Kinkadee Creek.

Photos 22A and B: At the location of Kinkadee Island (RM 10), many side channels have developed that pass around and through the island. Kinkadee Creek (shown in Photo 22A) is the largest side channel in this area and flows to the east creating the island. Currently, there are three entrances to Kinkadee Creek from the main channel. Each of these entrances have log jams that limit the amount of flow and coarse sediment entering the channel. However, recent flooding has widened the upstream-most entrance and the amount of flow entering this path is increasing. As the main channel continues to migrate towards the outside of a bend (shown in Photo 22B), the river has the potential to remove these log jams and the side channels would capture an even larger portion of the total flow (currently estimated at about 50% of the main channel flow). If the log jams were enlarged, the rate at which the main channel may overtake the side channel would be slowed. However, the risk of flooding would still exist on the island because of the numerous side channels throughout the island. Photos taken 10-2000.

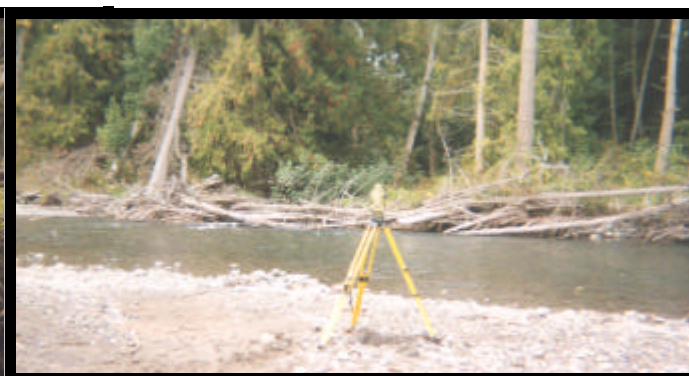
Photo 22B: Looking from main channel at side channel entrance on Kinkadee Island.

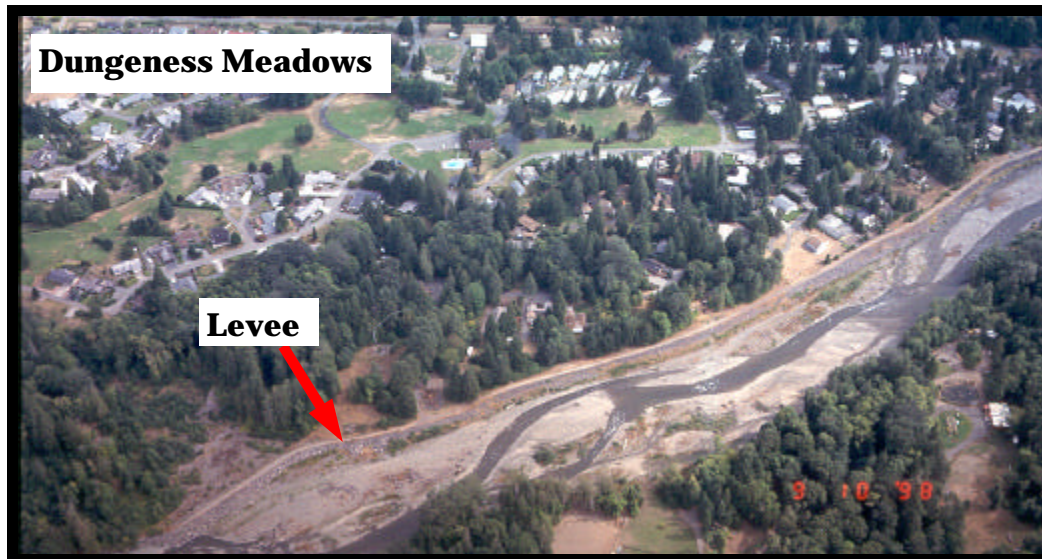
Photo 23: Levees have a large impact in the lower Dungeness River. The Dungeness Meadows levee (shown above) cuts off not only historic floodplain but also historic active channel (RM 7.5 to 8.5). The levees also increase flow depth, velocity, slope, and sediment transport capacity. This also results in the removal of large woody debris that could otherwise form stable log jams and scour pools. Bars are elevated in this reach due to the higher river stage caused by the levee. The Dungeness Meadows levee was extended downstream to block the entrance to a side channel and prevent flooding in the subdivision. To increase fish utilization while still protecting homes from flooding, the lower portion of the levee could be setback to the east side of Spring Creek. Another option would be to create a small opening in the levee that would limit flows but allow fish passage. Photo taken 9-10-98.

2. Haller Dike, RM 8.57 to 8.87 on west bank, originally a private levee but replaced and setback by the County in 1997 (see Figure 3A)
3. Dungeness Meadows Levee, RM 7.5 to 8.1 on east bank, private levee at Dungeness Meadows Neighborhood built in 1960s (Photo 23 – Photographic Overview)

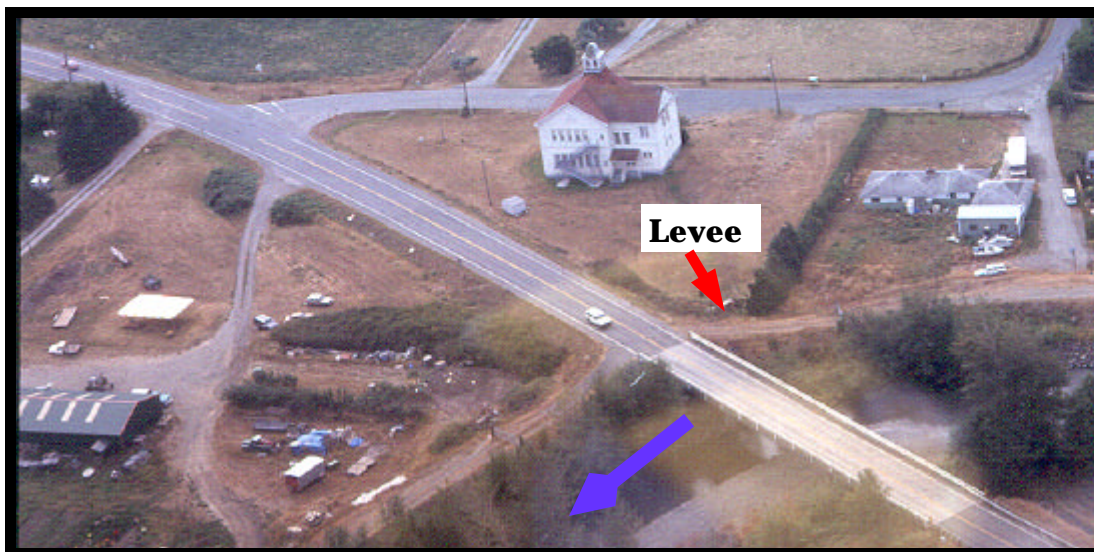
Photo 25: Schoolhouse Bridge (RM 0.8) is located at a natural constriction formed by glacial knobs. The river has likely flowed through these knobs for thousands of years. Prior to levee construction upstream of the bridge, flood flows would spill over river banks onto the floodplain. A portion of these flows would enter Meadowbrook Creek which flows into Dungeness Bay. Today, levees force all the water to pass under Schoolhouse Bridge. Photo taken 9-10-98.

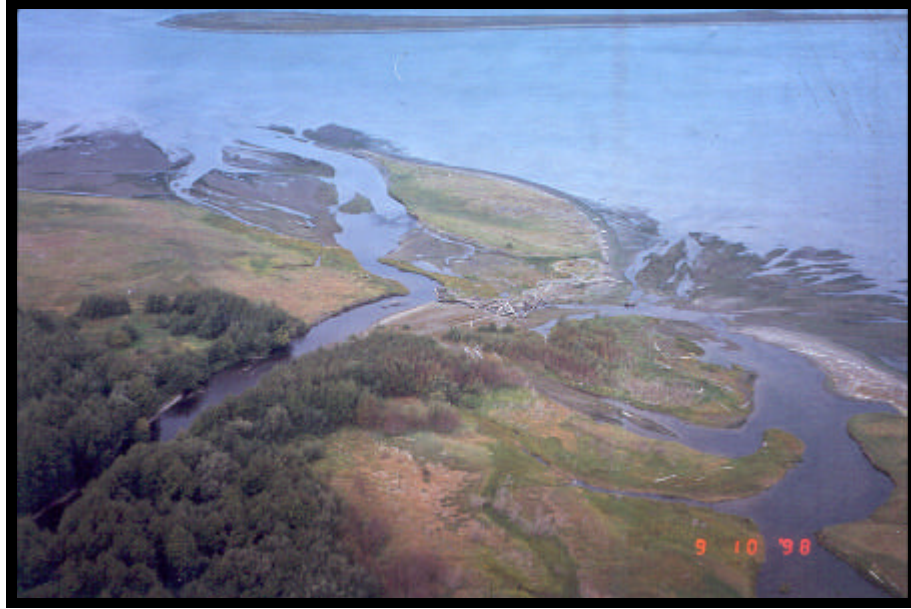
Photo 27: Historically, the Dungeness River formed a delta at its mouth and migrated back and forth over time. Historical levee development in the 1800's may have contributed to aggradation in the bay which resulted in moving the town of Dungeness to the east. The present levee development downstream of Schoolhouse Bridge has forced the river to flow into Dungeness Bay at one location. This also forces all of the sediment transported by the river to deposit in one location in the bay. Photo taken 9-10-98.

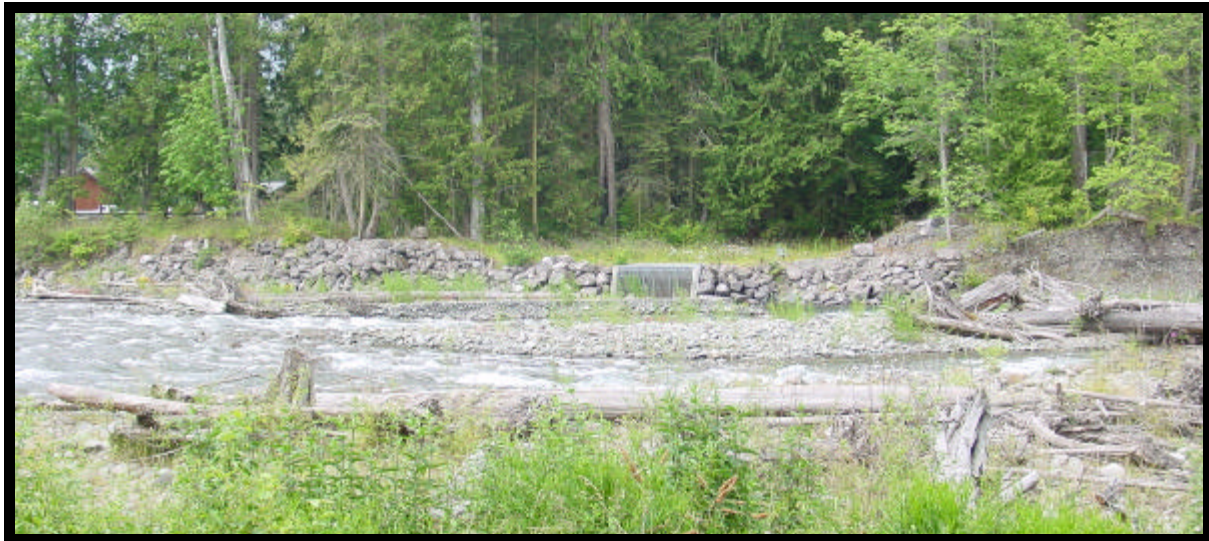
Photo 28: In addition to bridges and levees, irrigation diversions and bank protection as shown above are common features along the study reach. Bank protection does impact natural processes by preventing natural channel migration and recruitment of large woody debris. In some areas, rock has been placed on the banks of river terraces that are hundreds to thousands of years old. Although erosion of river terraces can be a natural process, the erosion can be accelerated by human impacts to the river. In some cases, protection of terraces can be considered a mitigation for one or more human impacts. Photo taken 6-28-01.

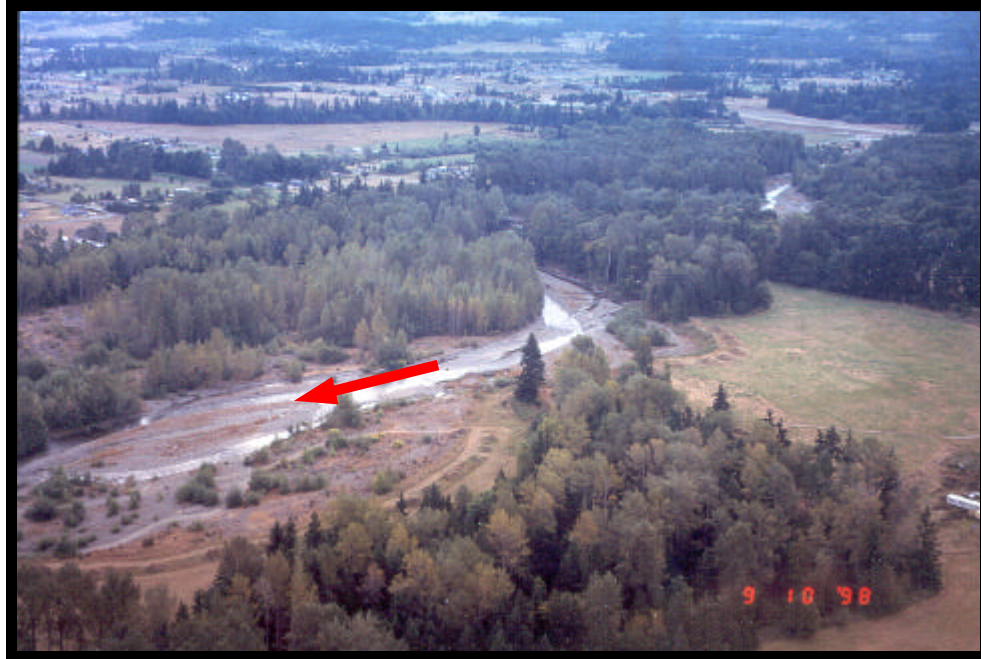
Photo 29: Clearing of riparian vegetation can reduce the strength of river bank materials and lead to accelerated channel migration and bank erosion. In this location just downstream of the Railroad Bridge, the vegetation on the west terrace was cleared sometime prior to the 1942-43 aerial photograph. Between 1942-43 and 2000, a maximum width of 760 feet of the left bank was eroded by the river. Photo taken 9-10-98.

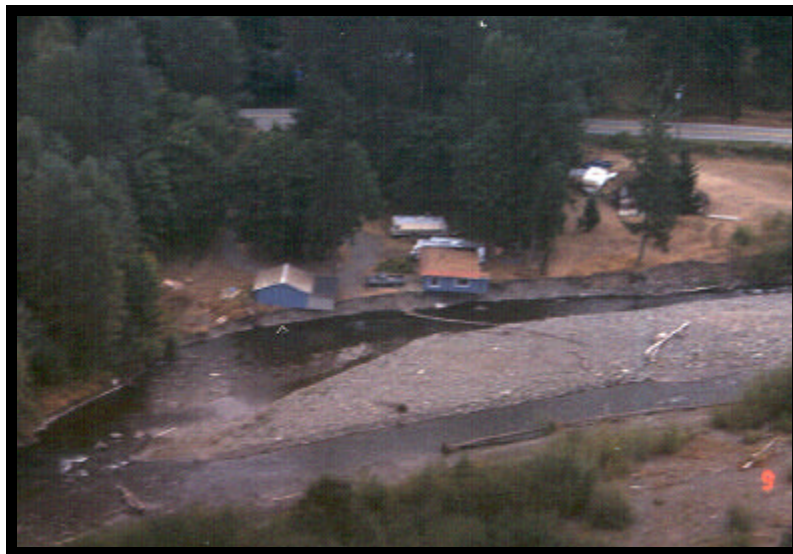
Photo 30: While development in the floodplain can impact natural processes, the river can also impact development in the flood plain (such as at RM 9.2 in photo 30). Management decisions to implement river restoration have the tough task of balancing natural river processes with the protection of existing infrastructure. Photo taken 9-10-98.

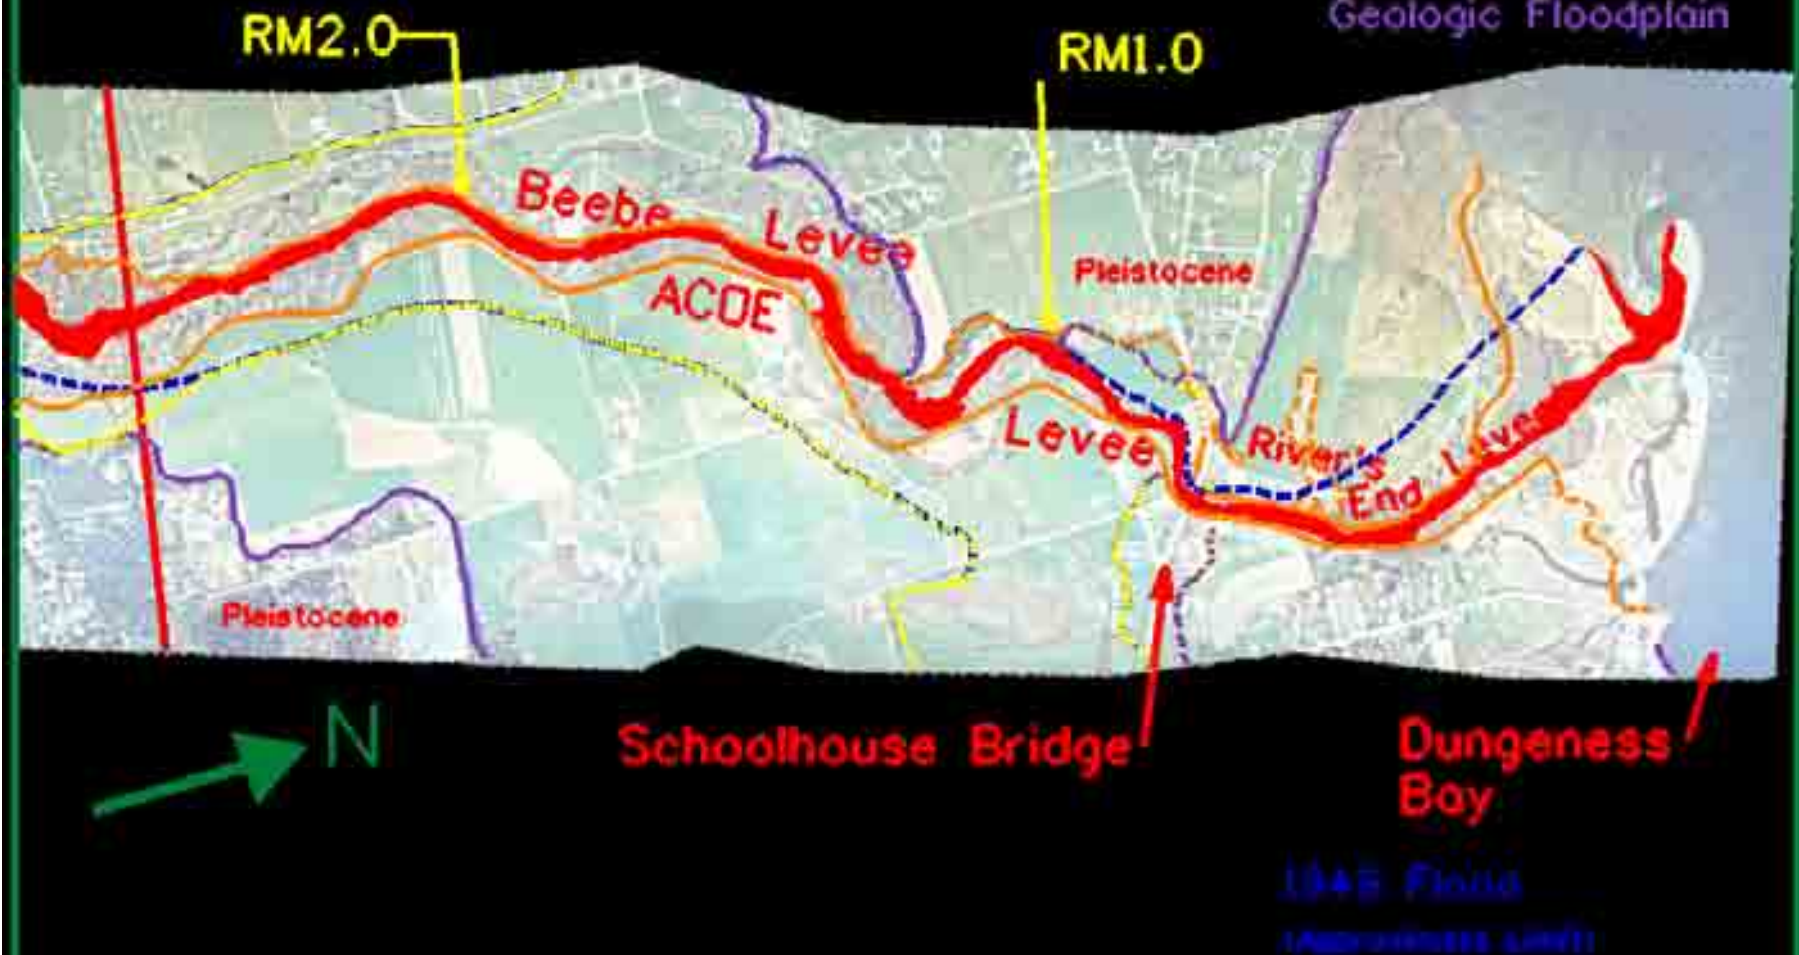
Reach 1 -- Floodplains

Channel
Present Floodplain
Prehistoric Floodplain
Geologic Floodplain

Base is a mosaic of 2000 ortho-photographs.

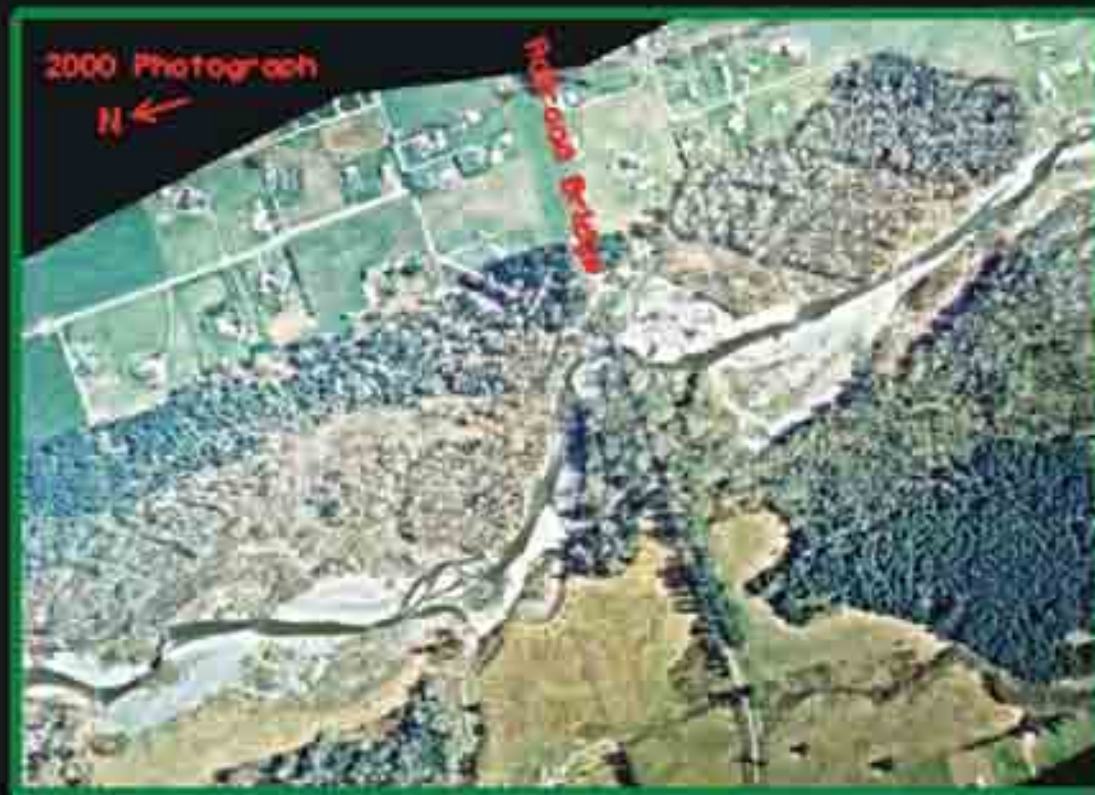
Figure 26. Bank erosion in the section of Reach 3 near Railroad Bridge. Eroded portions of the bank are for the time intervals between aerial photographs as shown.

The upstream boundary of Reach 5 is at RM 10.5 near the fish hatchery, the upstream extent of the study reach (Figure 3B). The downstream boundary of Reach 5 is at RM9, where the river exits the foothills of the Olympic Mountains and the flood plain markedly widens. Because the river in Reach 5 flows within the foothills, the banks of this reach are generally well defined by rock on the east bank and high deposits of glacial sediments on the west bank (Figure 26).
