PHYSICAL PROCESSES, HUMAN IMPACTS, AND RESTORATION ISSUES OF THE LOWER DUNGENESS RIVER

Clallam County, Washington

**Prepared for Jamestown S’Klallam Tribe
by the
U.S. Department of the Interior
Bureau of Reclamation
May 2002**

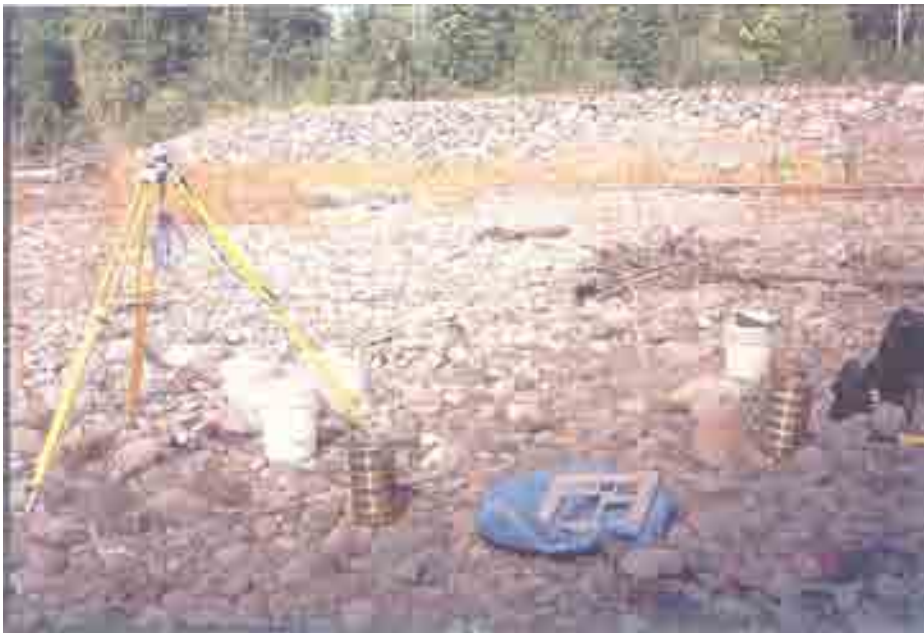
Figure D.1. View of sampling setup at locality DRsed-113 near the downstream end of the Dungeness Meadows levee, seen in the background. Two sets of 5-gallon buckets and sieves were used to expedite sampling of the gravel bar.

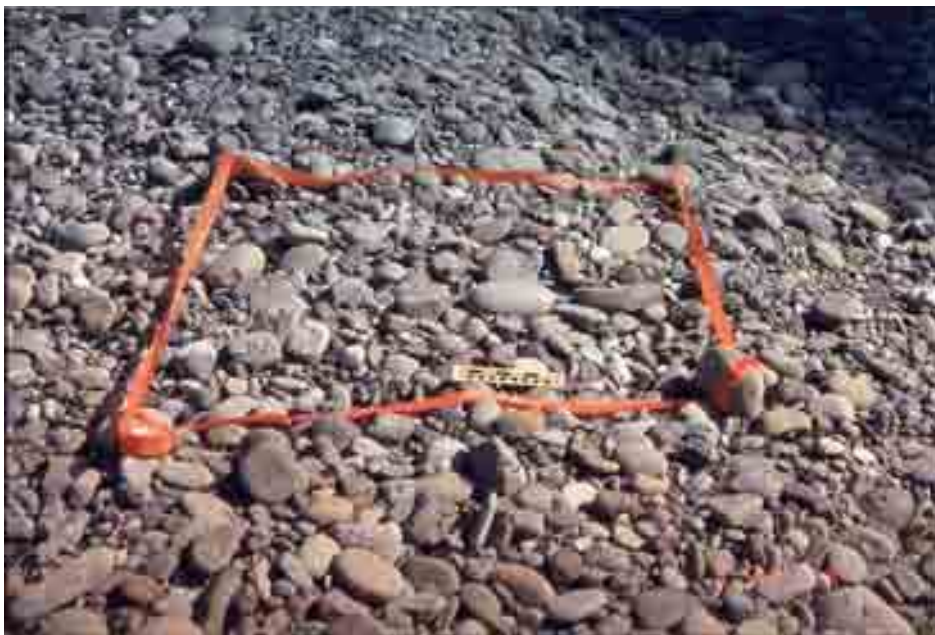
Figure D.2. Surface of unvegetated gravel bar at Sample Locality DRsed-5B downstream from Woodcock Bridge. Our 1-meter square sample area was delineated by the flagging tape on the bar surface. The pavement was composed chiefly of gravel and cobbles and was about one particle diameter thick at this location. This pavement was excavated, sieved, and weighed before the underlying bed material was sampled.

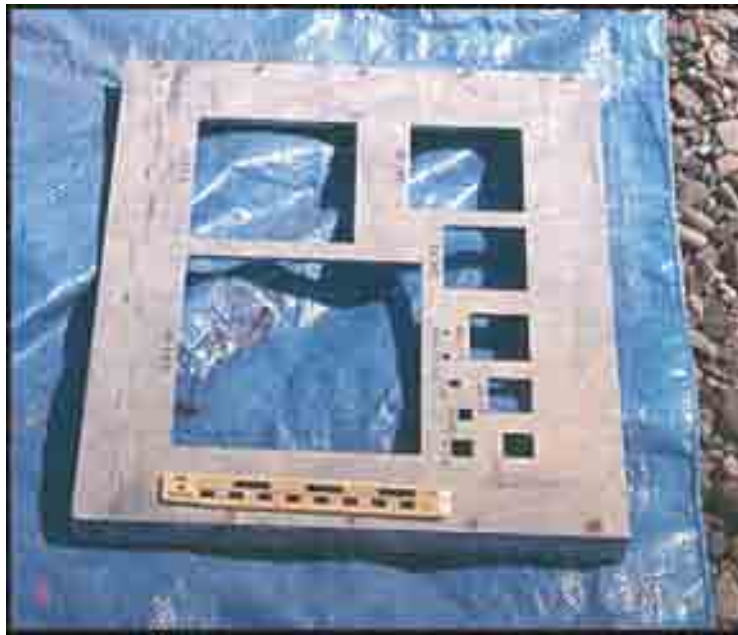
Figure D.3. Gravelometer, or pre-cut template, used to sort particles larger than the 32-mm sieve. The smallest opening through which a particle passes determines its size group. Size groups measured with the gravelometer were 32 to 63 mm, 63 to 90 mm, 90 to 128 mm, 128 to 180 mm, and larger than 180 mm. Rocks larger than 180 mm were weighed individually and then totaled to obtain the weight for that fraction.

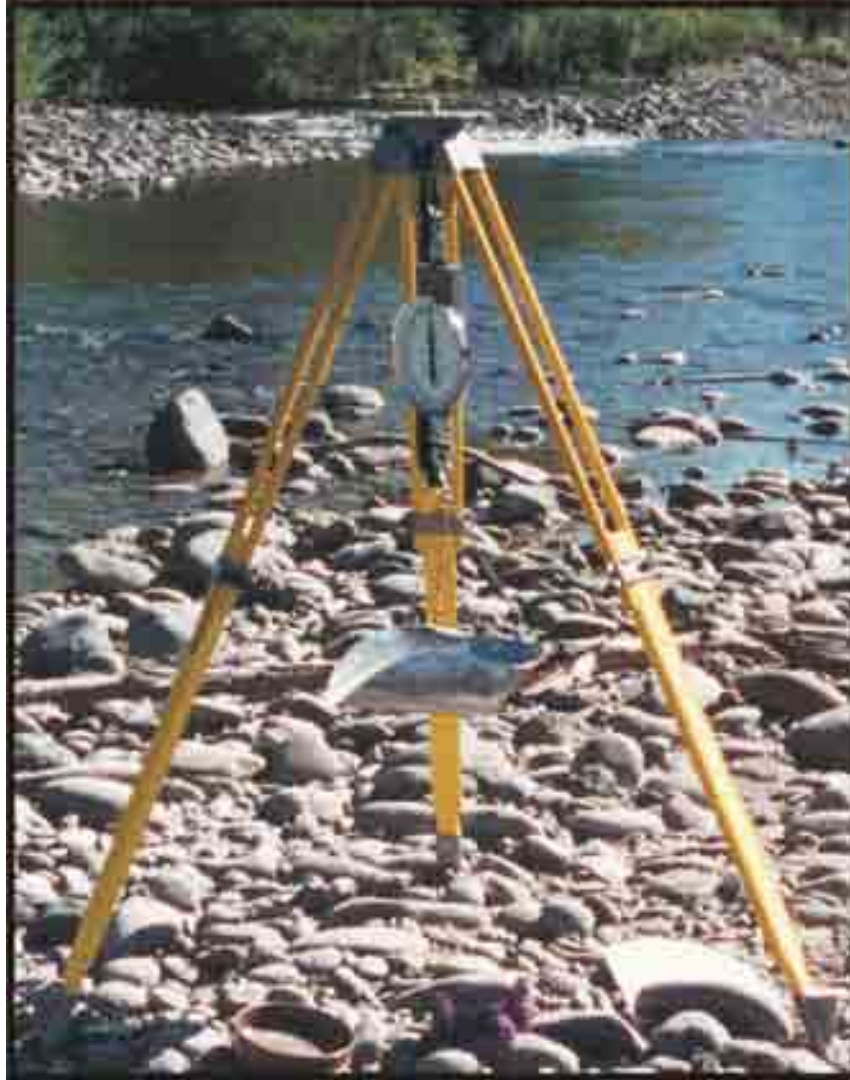
Figure D.5. View showing the scale suspended from a tripod which was used to weigh the sample in each size fraction. Samples too large for the pan were weighed in smaller portions and a cumulative weight was then calculated for the entire size fraction.

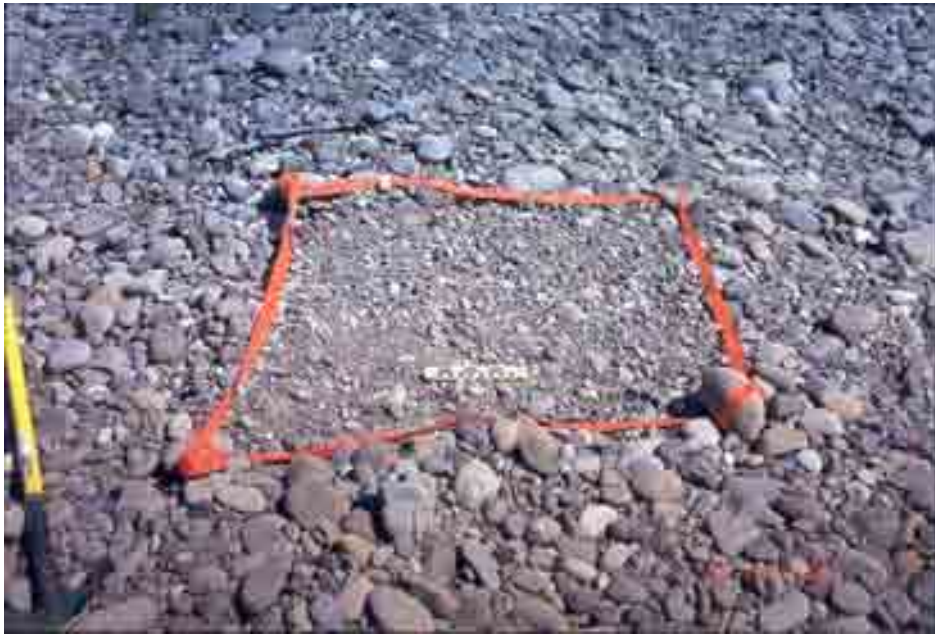
Figure D.6. Example of bed material exposed following excavation of the surface pavement layer at Sample Locality DRsed-5B. The thickness of the pavement was about one particle diameter at this location. The bed material beneath the pavement was markedly smaller than the pavement and is more representative of the material carried in the bed load of Dungeness River.

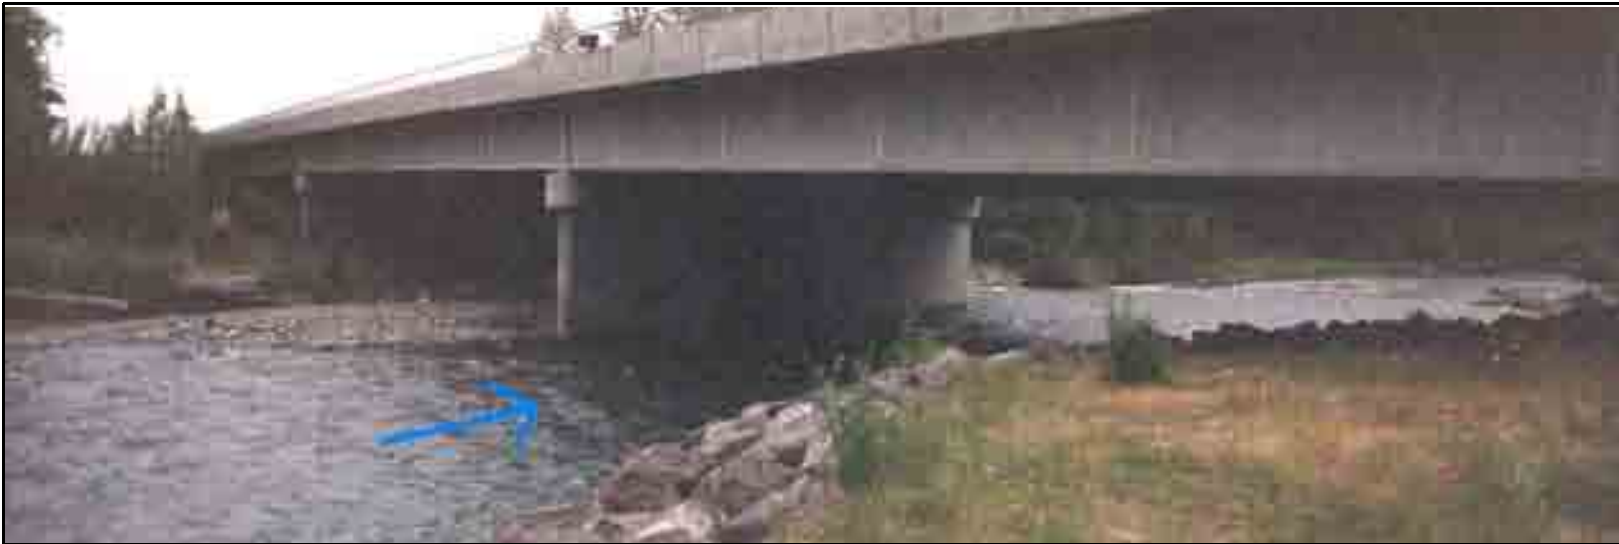
Figure E1. Looking downstream at USGS Gage Site on Highway 101 Bridge where sediment load measurements were done.

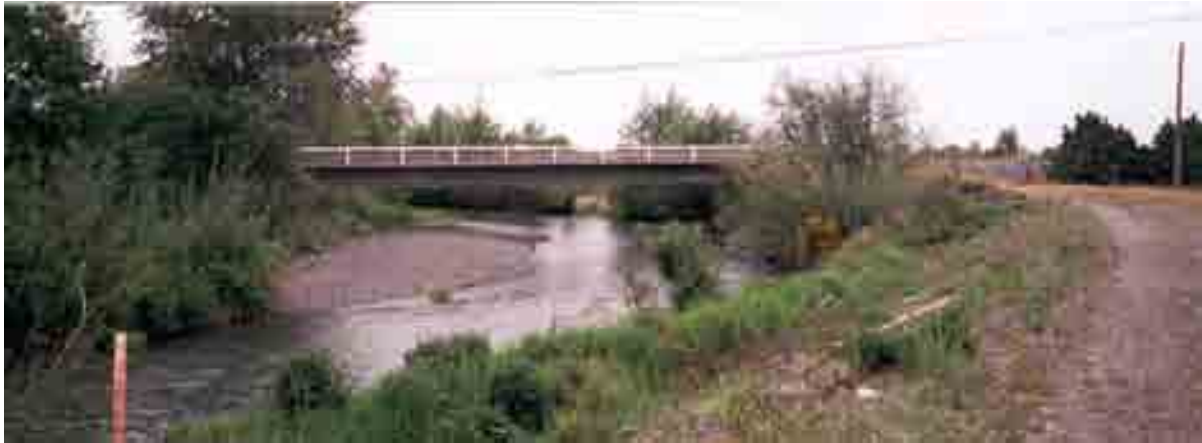
Figure 2. Looking downstream at Schoolhouse Bridge from Corps levee in May, 1998.

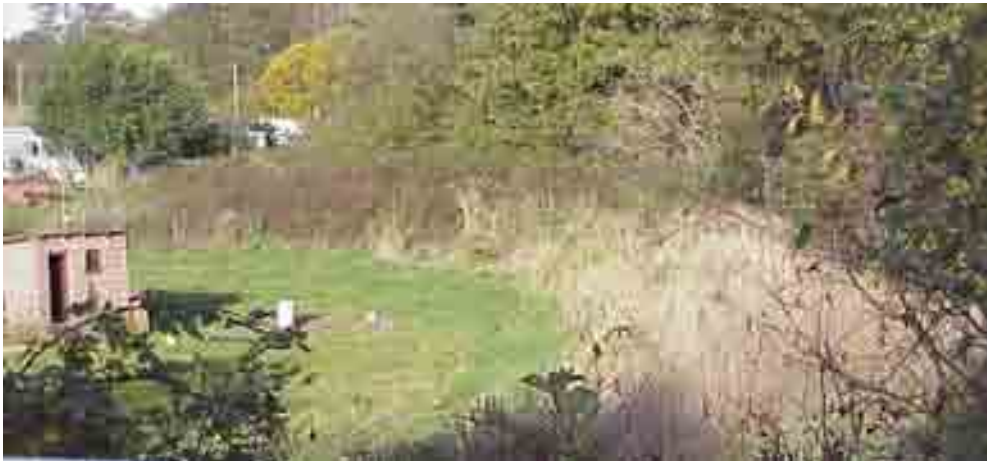
Figure 3. Looking downstream from Schoolhouse Bridge at west floodplain and River's End levee (right side of picture).

as River's End levee) exists along the west terrace. The height of the River's End levee is significantly lower than the Corps levee (figure 3). The River's End levee continues downstream from Schoolhouse Bridge (RM 0.8) and ends near RM 0.4, just upstream of where a side channel passes flows to the northwest during high flows and/or tides.

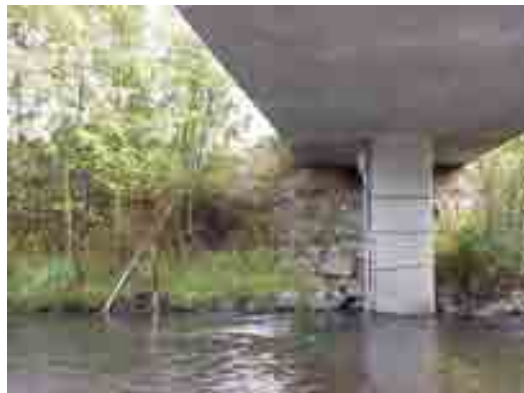
Figure 4. Looking at east bank below Schoolhouse Bridge showing USGS and DOE staff gages.

Discharge data are recorded at the United States Geological Survey (USGS) gaging station located at River Mile (RM) 11.8, almost 2 miles upstream of the state fish hatchery. In addition, two temporary gages have been established at the Schoolhouse Bridge by the Washington Department of Ecology (DOE) and the USGS (figure 4). DOE data available for the past year include velocity, water surface elevation, discharge, and cross section measurements. USGS gage data consisting of cross section measurements, water surface elevations, and discharge measurements are estimated to be available in November 2000. These data will be used to evaluate short-term changes in channel bottom at the bridge site. Also, water surface elevation measurements from the Schoolhouse Bridge gaging stations may help in evaluating the influence of tides at the bridge site.

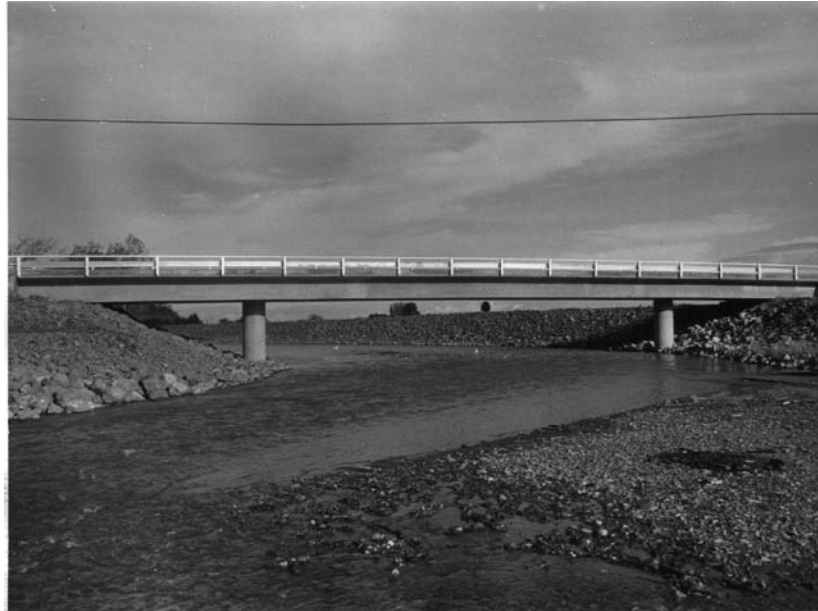
Figure 6. View downstream showing Schoolhouse Bridge after completion of construction and channel widening in 1964. Note the broad, flat configuration of the river channel bottom following channel widening. The Army Corps of Engineers flood-control levee is present on the east terrace. Photograph courtesy of the Clallam County Road Department.

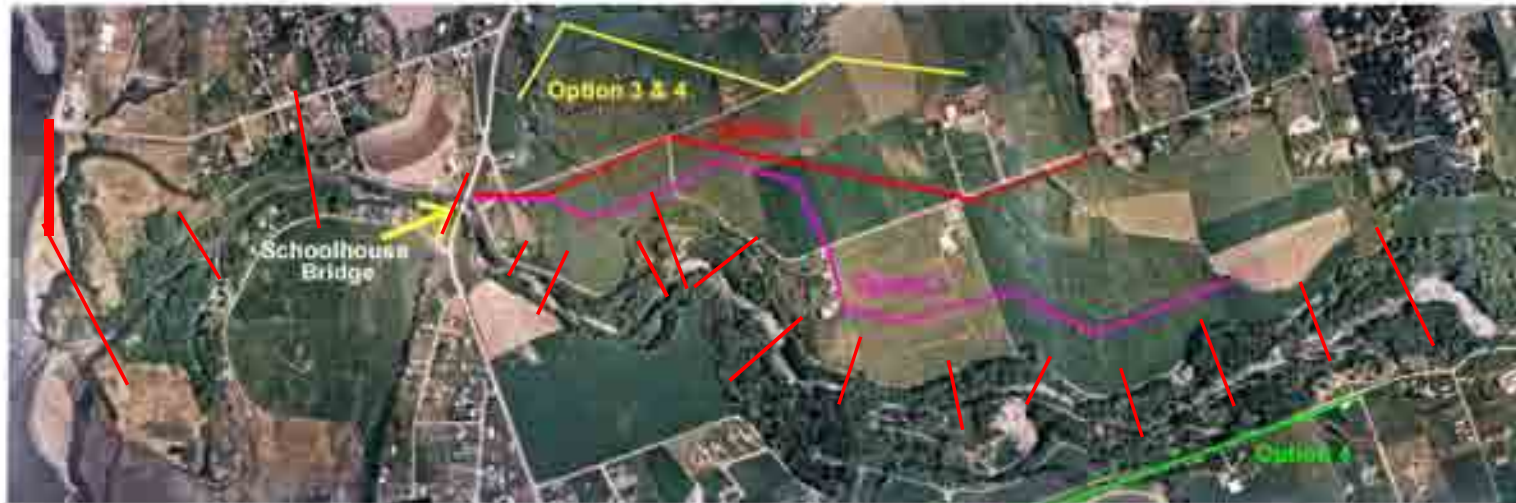
Figure 9. Dungeness River Levee Setback Options. XS's Shown in Red (1 at mouth in sequential order upstream to 17).

HEC-RAS version 2.2, a hydraulic model developed by the ACOE, was used to model both 1930's and existing conditions based on the available data. The HEC-RAS model performs water surface profile and other hydraulic calculations for one-dimensional steady flow. The model predicts river stage and other hydraulic properties at each cross section along the river and for any specified discharge. The steady flow component of the HEC-RAS model is capable of modeling subcritical, critical, supercritical, and mixed-flow regimes. For this 2.7 river mile reach extending from the upstream end of the ACOE levee downstream to the mouth of the Dungeness River, the model was forced to work in the subcritical and critical flow regimes. Cross section locations used in the model are shown later in the report in figure 9.

Option Number	Description of alternative
1	Upstream of Schoolhouse Bridge, setback the ACOE levee 500 feet from the current location as shown in figure 9
2	Upstream of Schoolhouse Bridge, setback the ACOE levee to Towne Road as shown in figure 9
3	Upstream of Schoolhouse Bridge, setback the ACOE levee to the west side of Meadowbrook Creek as shown in figure 9
4	Upstream of Schoolhouse Bridge, setback the ACOE levee as in Option 3, and setback the Olympic Game Farm levee to Ward Road as shown in figure 9

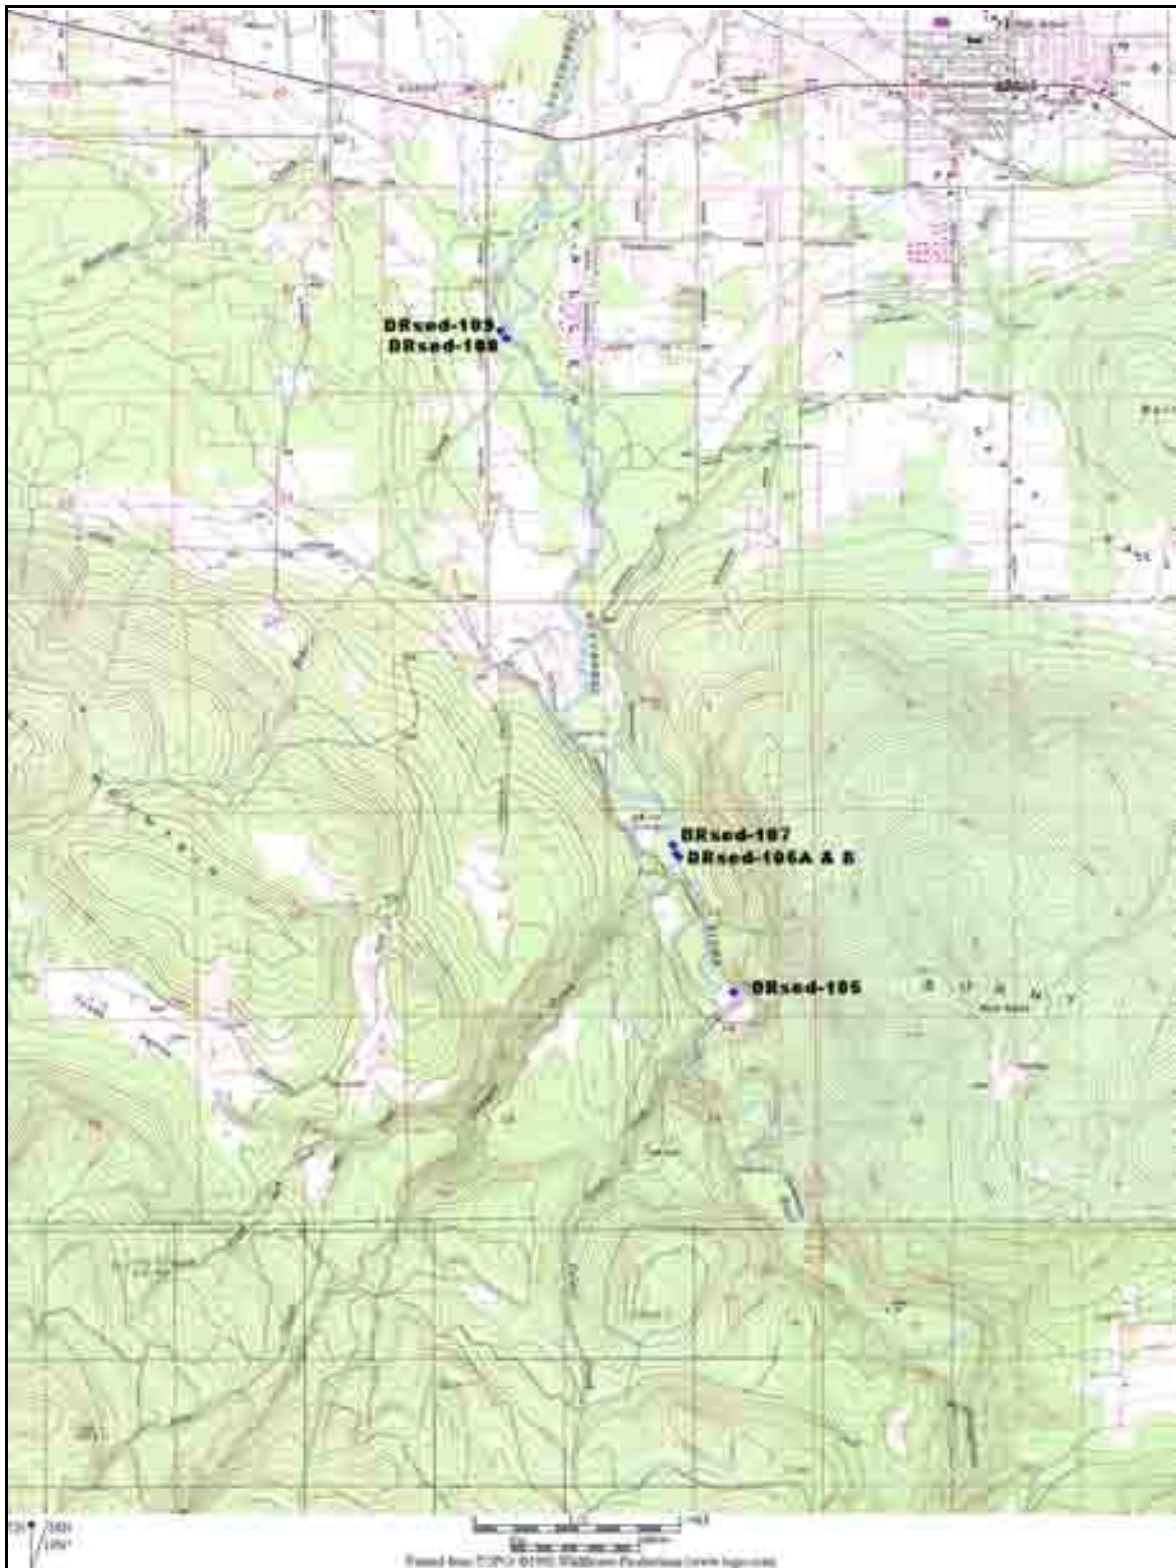
Figure 2. Location of sediment sample sites on the lower Dungeness River from the U.S. Geological Survey stream gaging station to U.S. Highway 101.

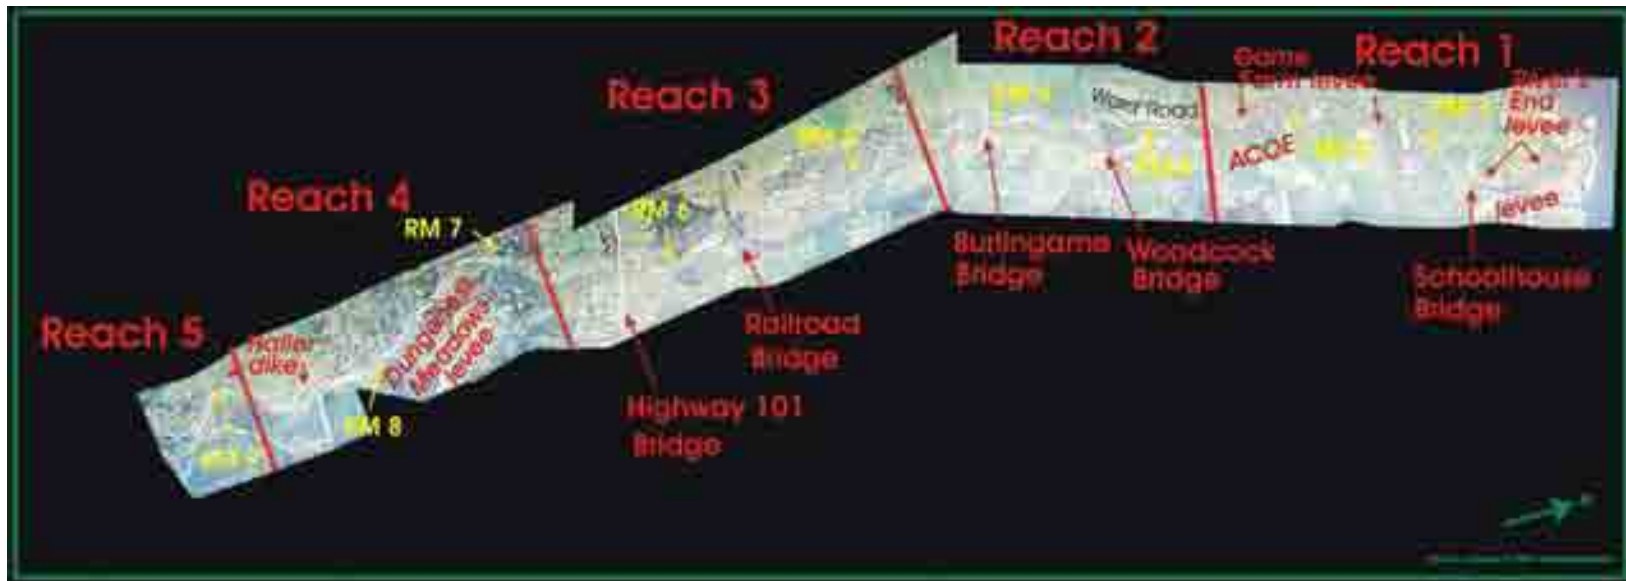
Figure O-1. The five study reaches in the lower 10.5 miles of the Dungeness River basin shown on a mosaic of ortho-photographs taken in 2000.

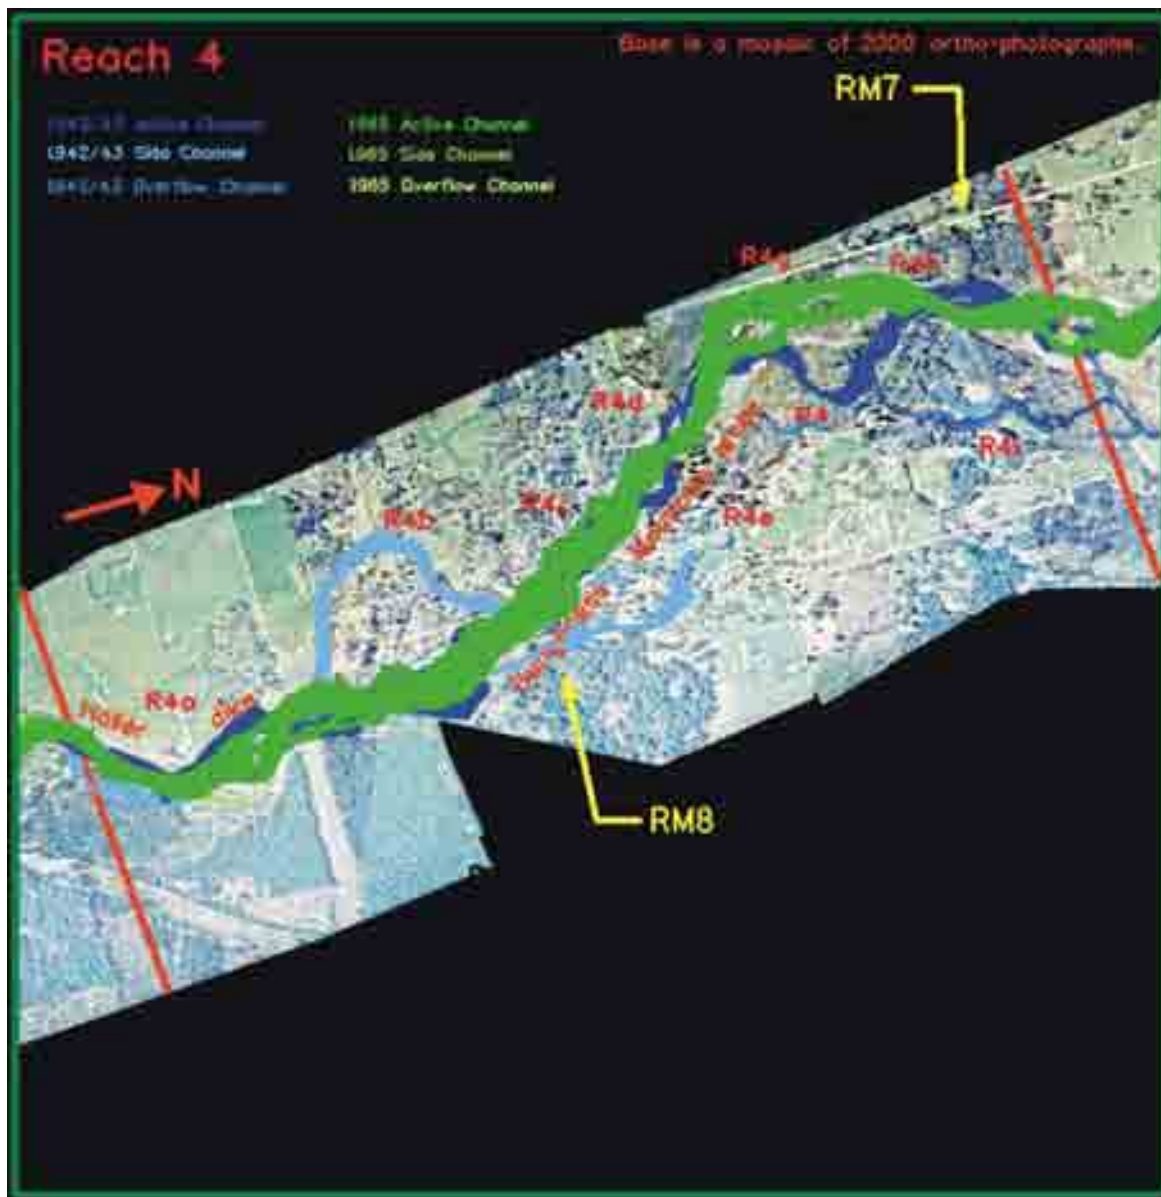
Figure O-7. Active channels, side channels, and overflow channels mapped from aerial photographs taken in 1942/43 and 1965 for Reach 4. Differences in the side and overflow channels may reflect their expression on the photographs rather than changes in the channels.

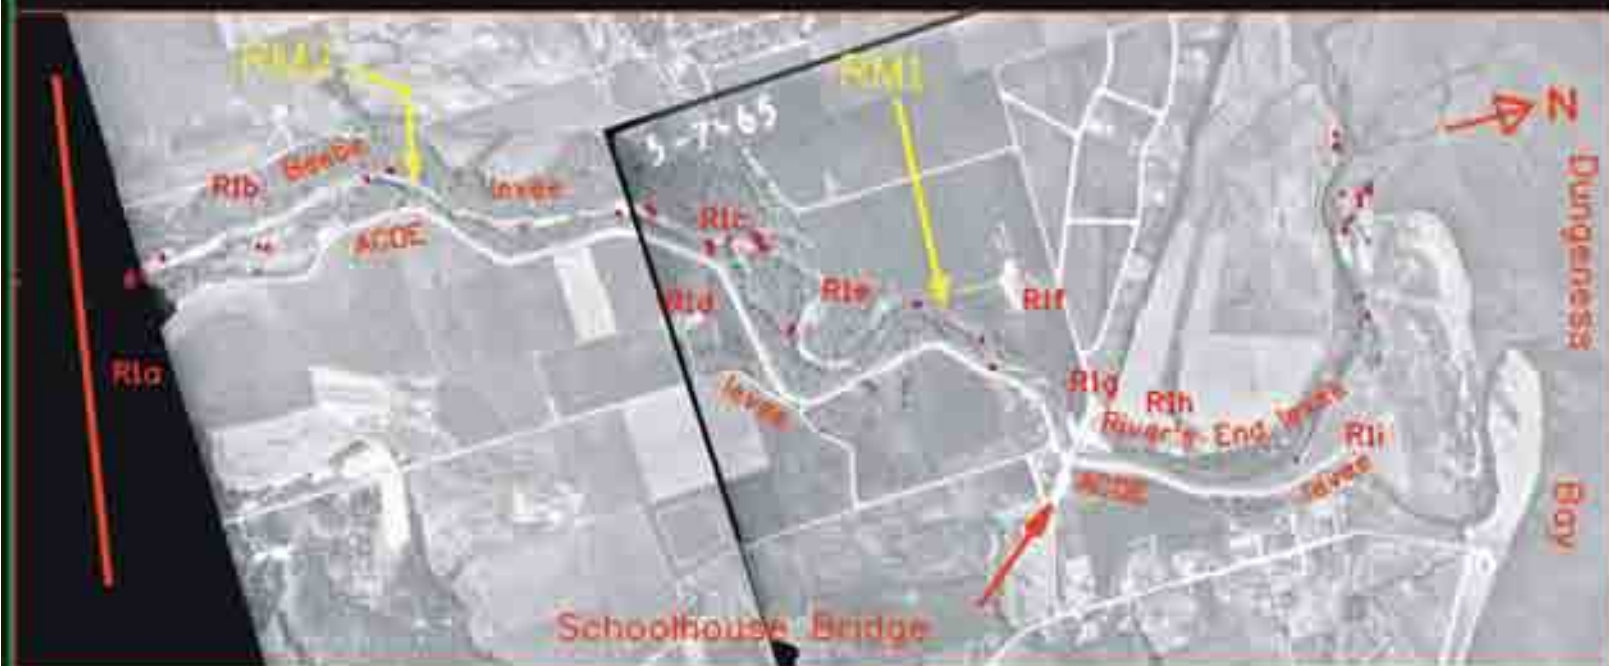
Figure O-32. Woody debris in the active channel and side channels for Reach 1. Both large stacks of wood and single logs that are visible on aerial photographs taken in 1965 are shown. Debris is shown on a mosaic of aerial photographs taken in 1965.

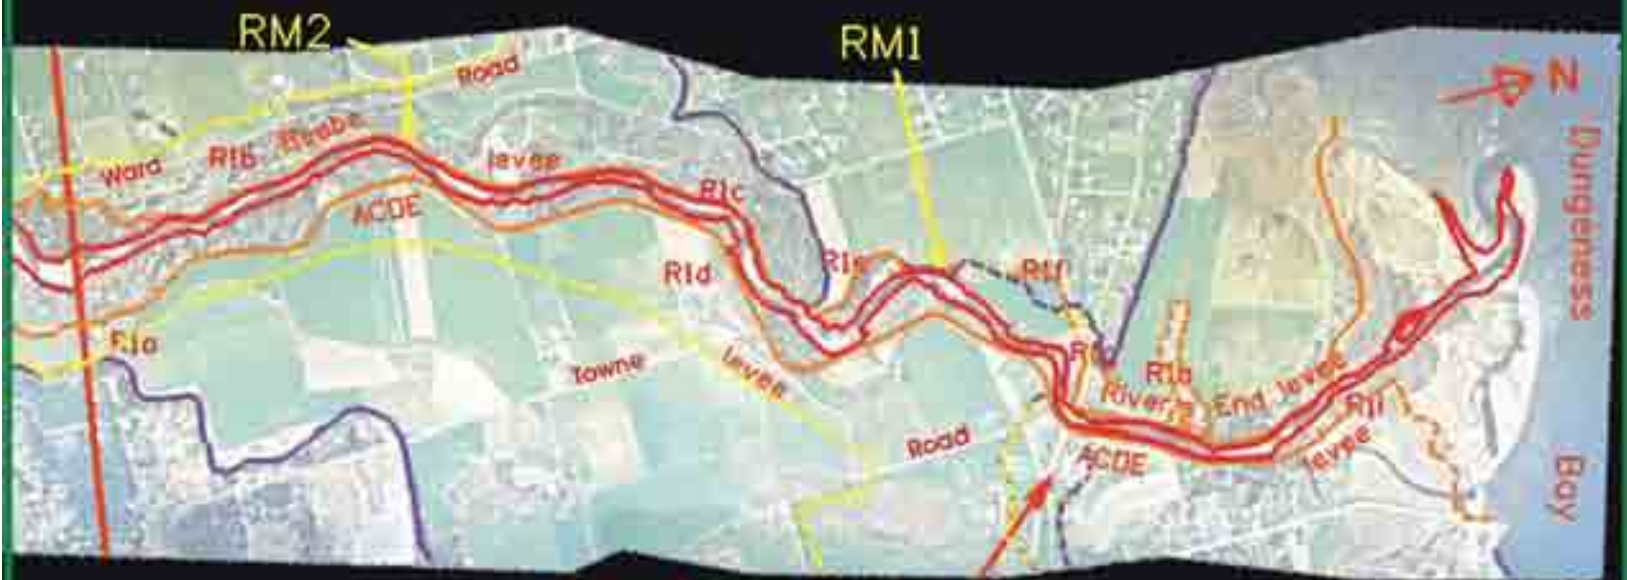
2000 Active Channel
Boundaries of Present Channel
Boundaries of Prehistoric Channel
Boundaries of Geologic Facies

Figure O-33. Active channel and the boundaries of the present, prehistoric, and geologic facies interpreted for Reach 1 from aerial photographs taken in 1942/43, 1965, and 2000. Boundaries are dashed where approximately located and dotted where unclear. Beebe levee is the same as the Olympic Game Farm levee.

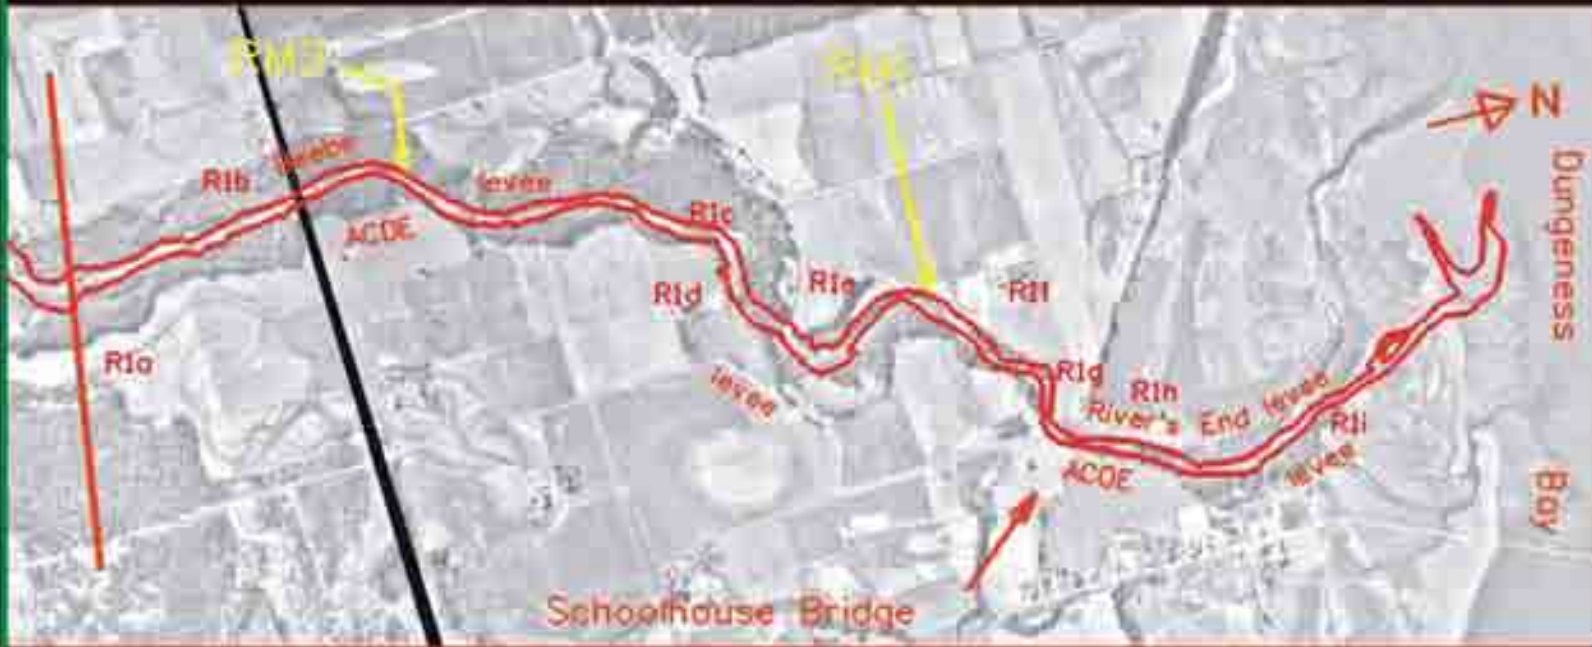
Figure O-35. Active channel that was mapped from aerial photographs taken in 2000 for Reach 1 and shown on aerial photographs taken in 1942/43. Note the similarity in the locations of the active channels in the two years.

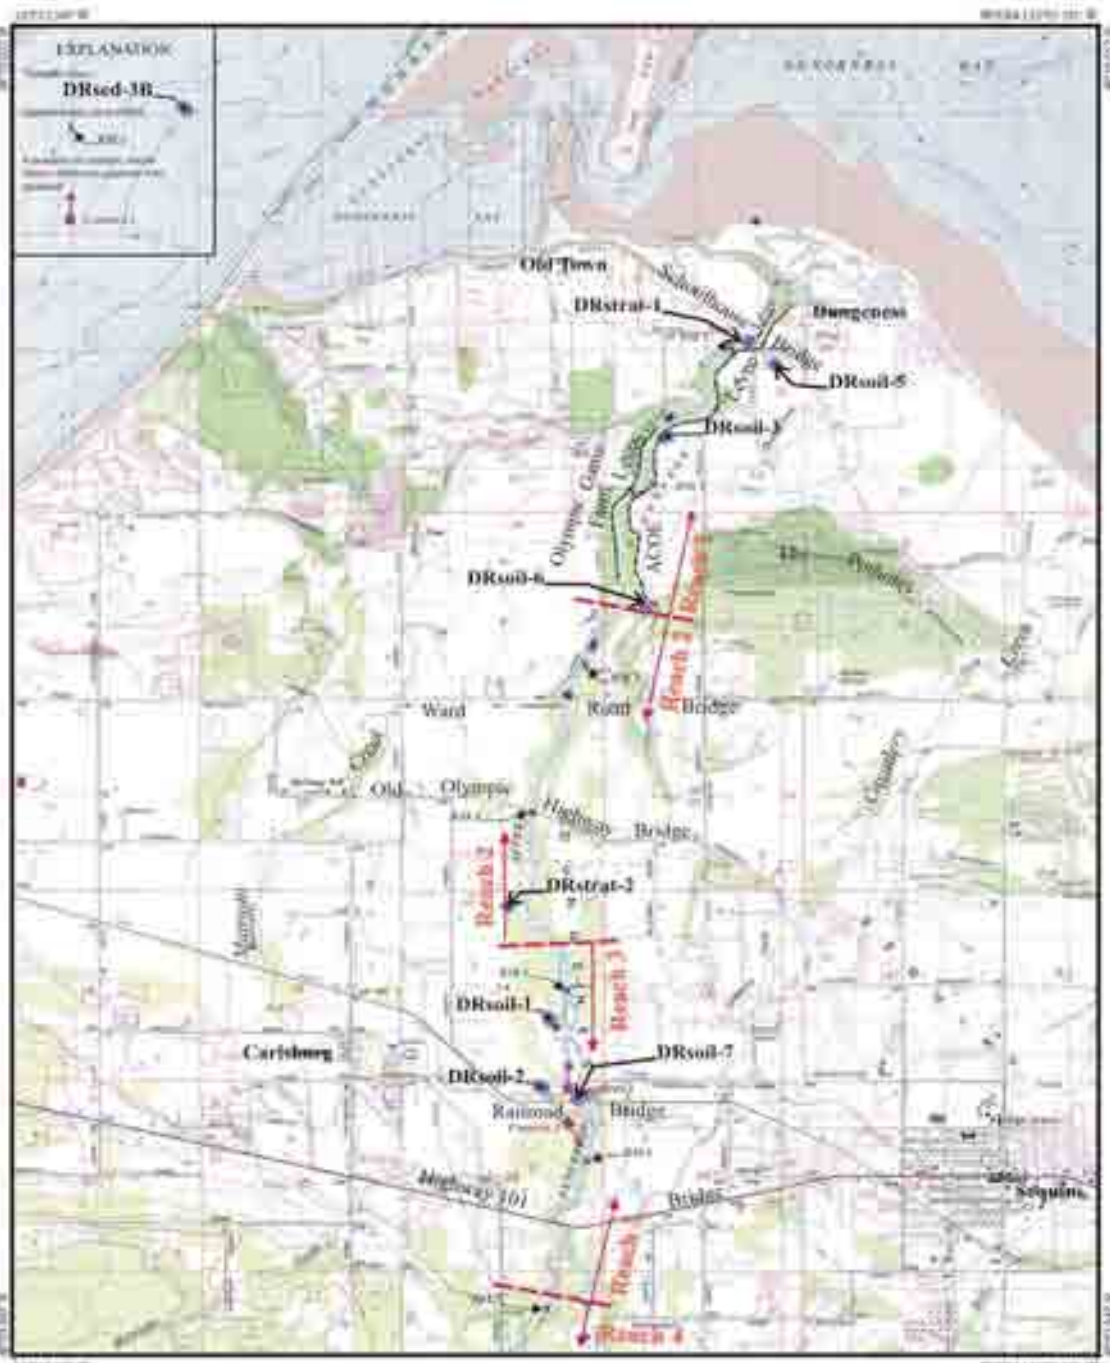
Figure Q-1. Location map of the northern portion of the study reach showing localities where stratigraphic and soil descriptions were done. Locality DRsoil-4 is along Fish Hatchery Road upstream of the area shown.

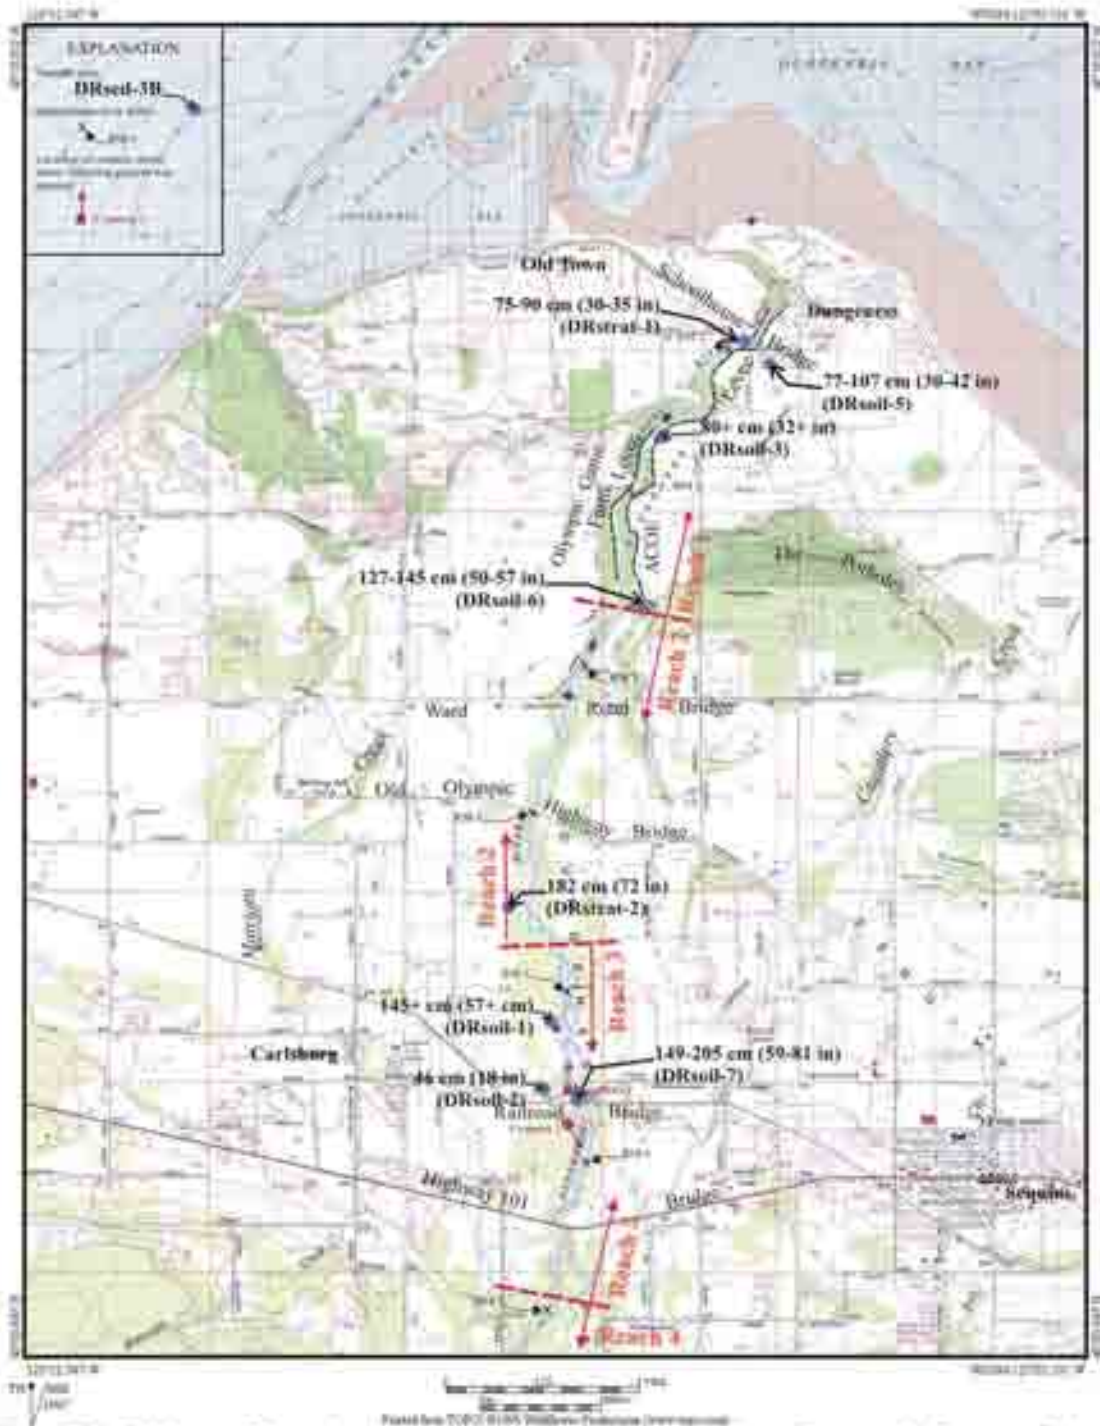
Figure Q-2. Thickness of fine-grained alluvium (overbank deposits) on surfaces adjacent to the Dungeness River
