Jimmycomelately Ecosystem Restoration

Lessons Learned Report

Jamestown S'Klallam Tribe
1033 Old Blyn Highway
Sequim, WA 98382

October 31, 2008

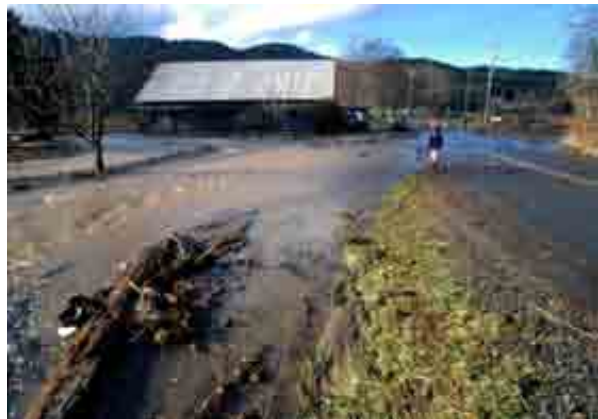
Flood waters overtop Old Blyn Highway, New Year’s Day 1997
(Randy Johnson)

It was New Year’s Eve 1996 and the entire flood volume of the Jimmycomelately Creek watershed could no longer squeeze through two undersized 6-foot diameter box culverts. Decades of land and creek alterations had finally come to a head. The Jimmycomelately ecosystem was out of whack.

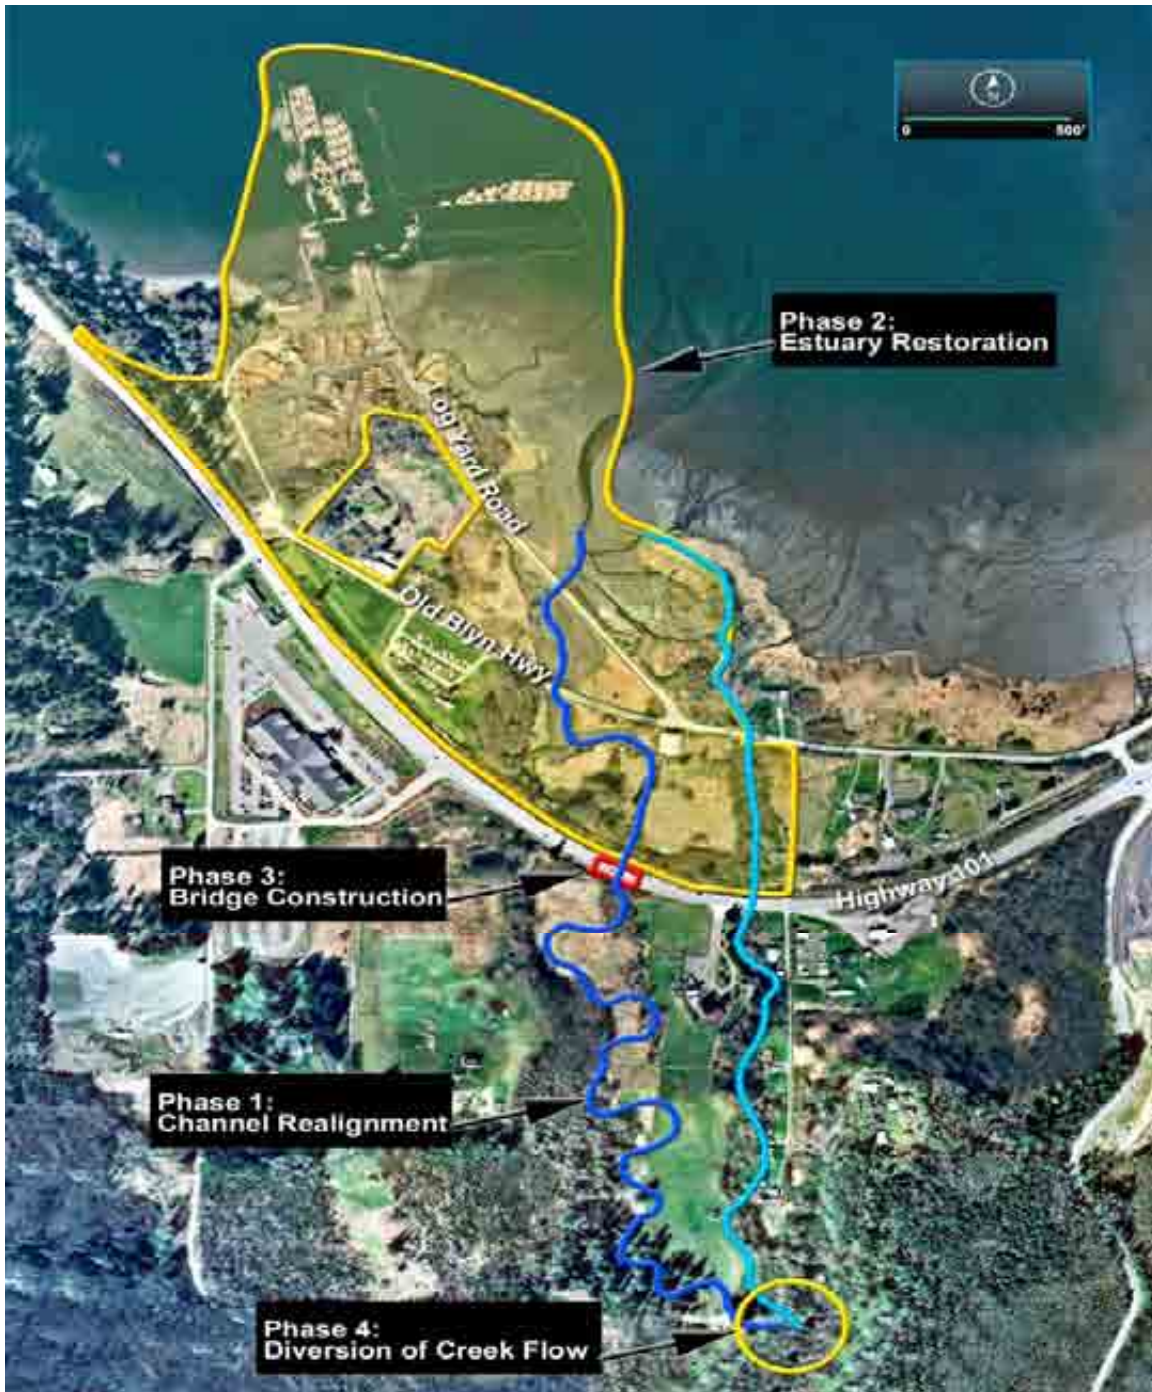
The Four Phases of the Jimmy Project (Randy Johnson)

2000 Estimated	2002 Revised	2006 Actual
Restoration Planning	'97 to '01	'97 to '02	'97 to '05
Channel Realignment	'01	'02	'02 to '04
Estuary Restoration	'01 to '02	'02 to '03	'03 to '05
Bridge Replacement	'01	'03	'04
Diversion of Existing Creek Flow	'02	'03	'04/'05

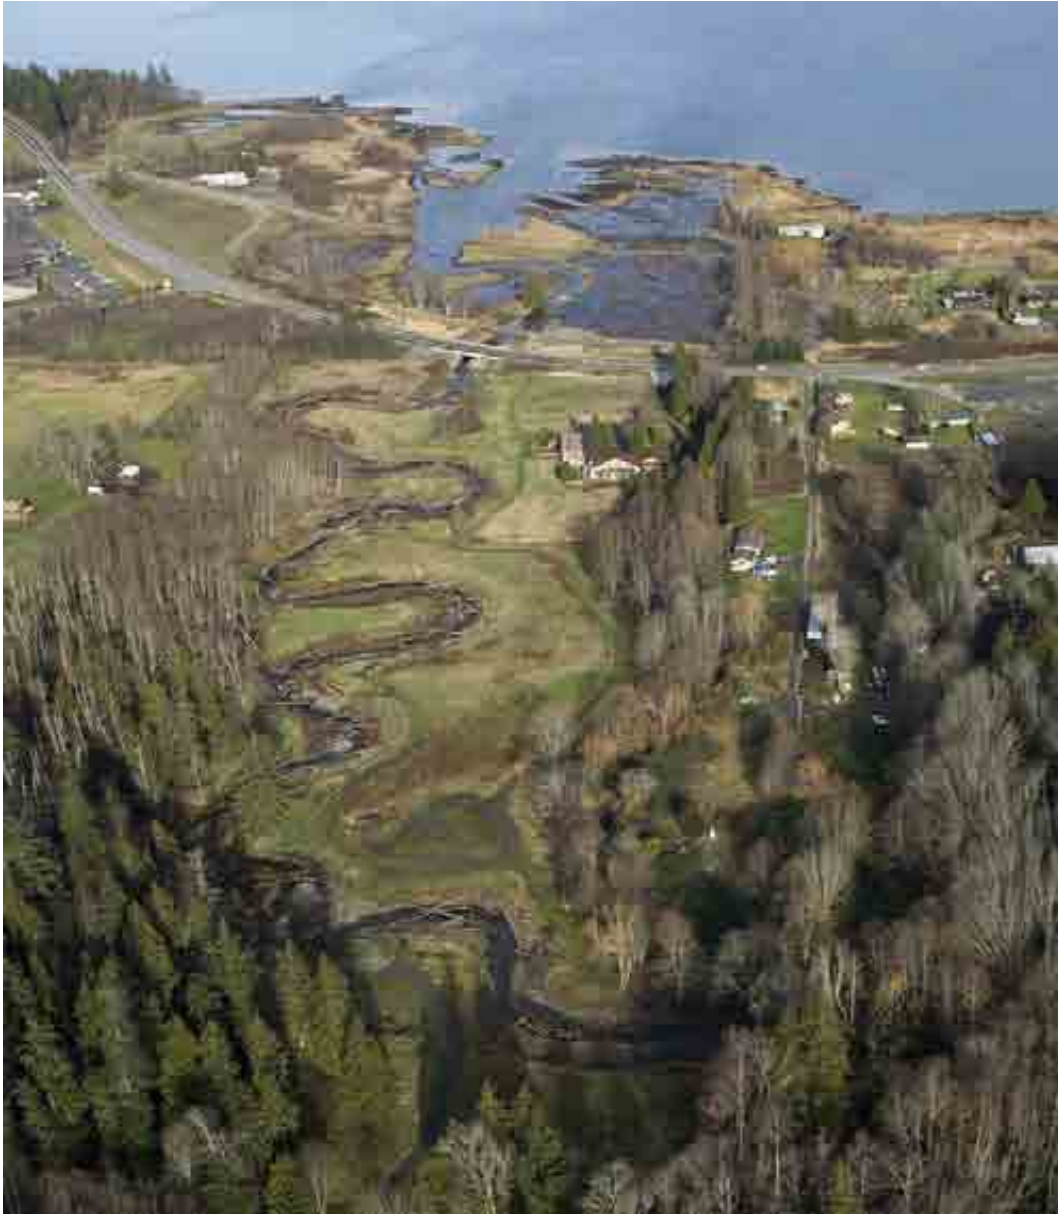
Oblique aerial photo of the restored Jimmycomelately Creek and Estuary in 2006
(David Woodcock, Greywolf Photography)

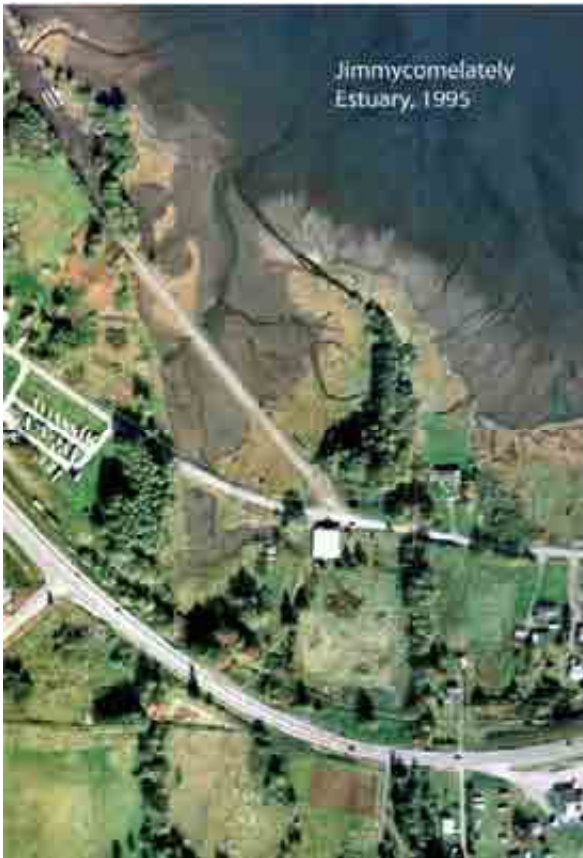
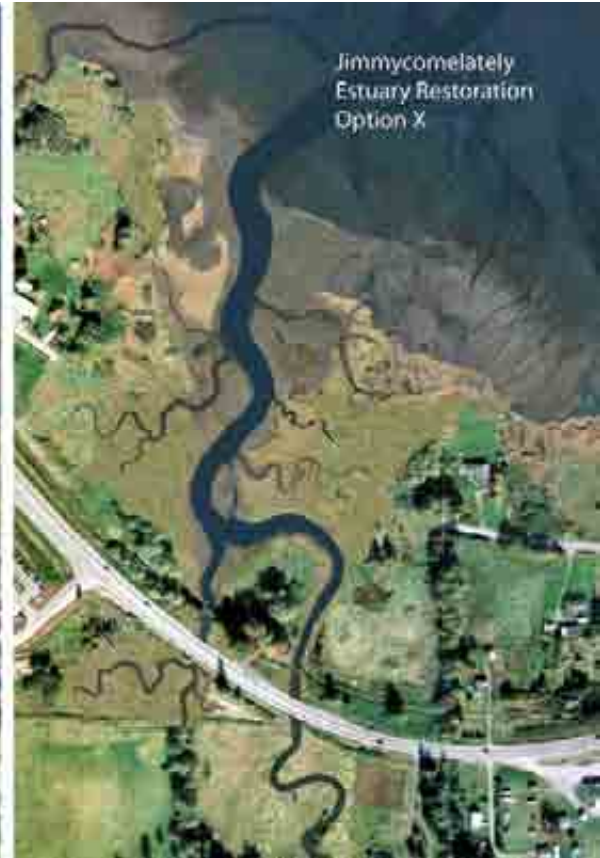
Option X Graphic (Randy Johnson)

The Option X graphic was a communication breakthrough. Viewing the graphic allowed anyone to gain a clear understanding of the restoration concept in moments. We found that the Option X vision appealed strongly to people. Although developed to simply depict the restoration concept, the graphic also became a powerful marketing tool. The original Option X graphic was eventually refined and used innumerable times for a variety of purposes.

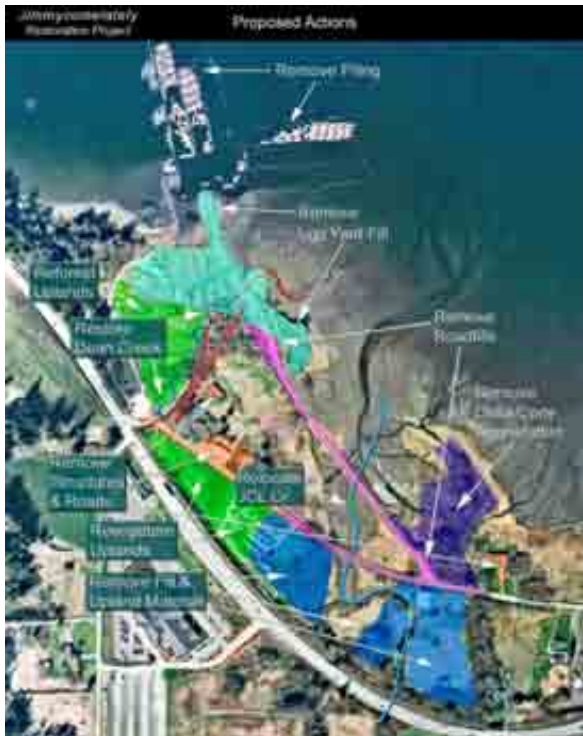
Aerial photo with graphic overlay used to show proposed actions (Randy Johnson)

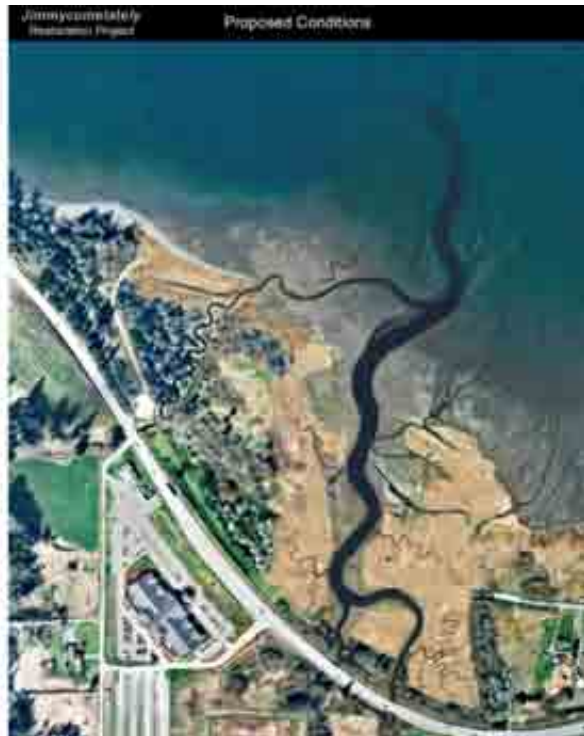
Altered photo used to depict proposed conditions (Randy Johnson)

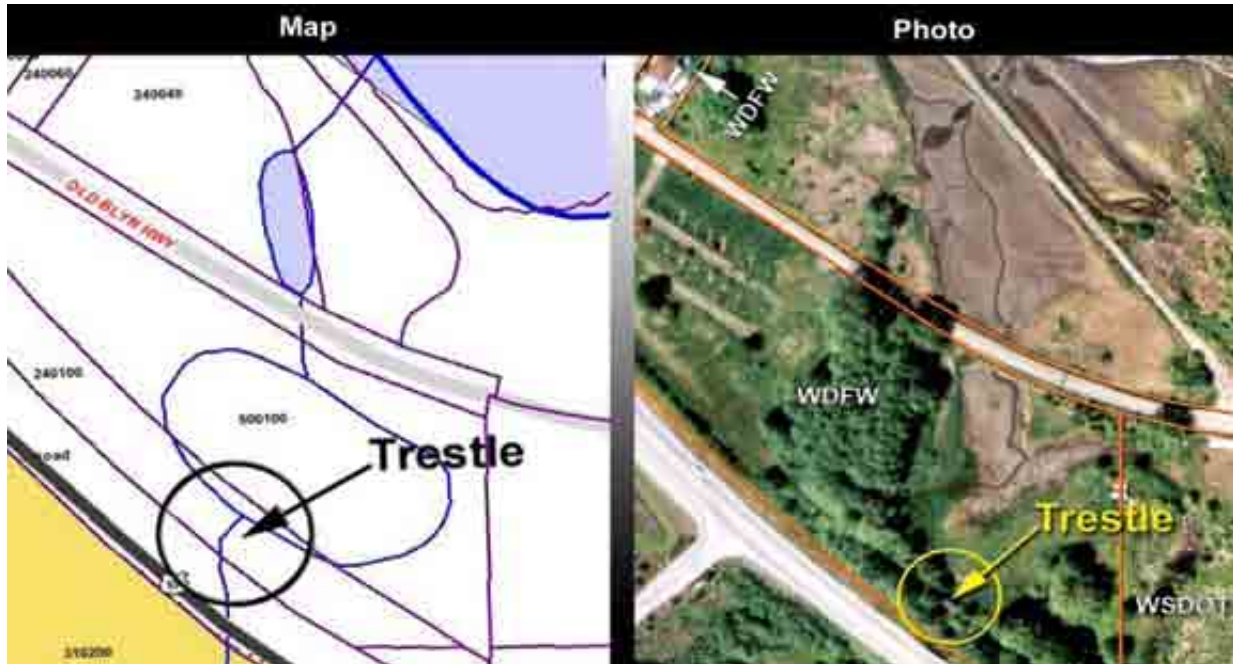
Comparison of a map and aerial photo showing the same project element (Randy Johnson)

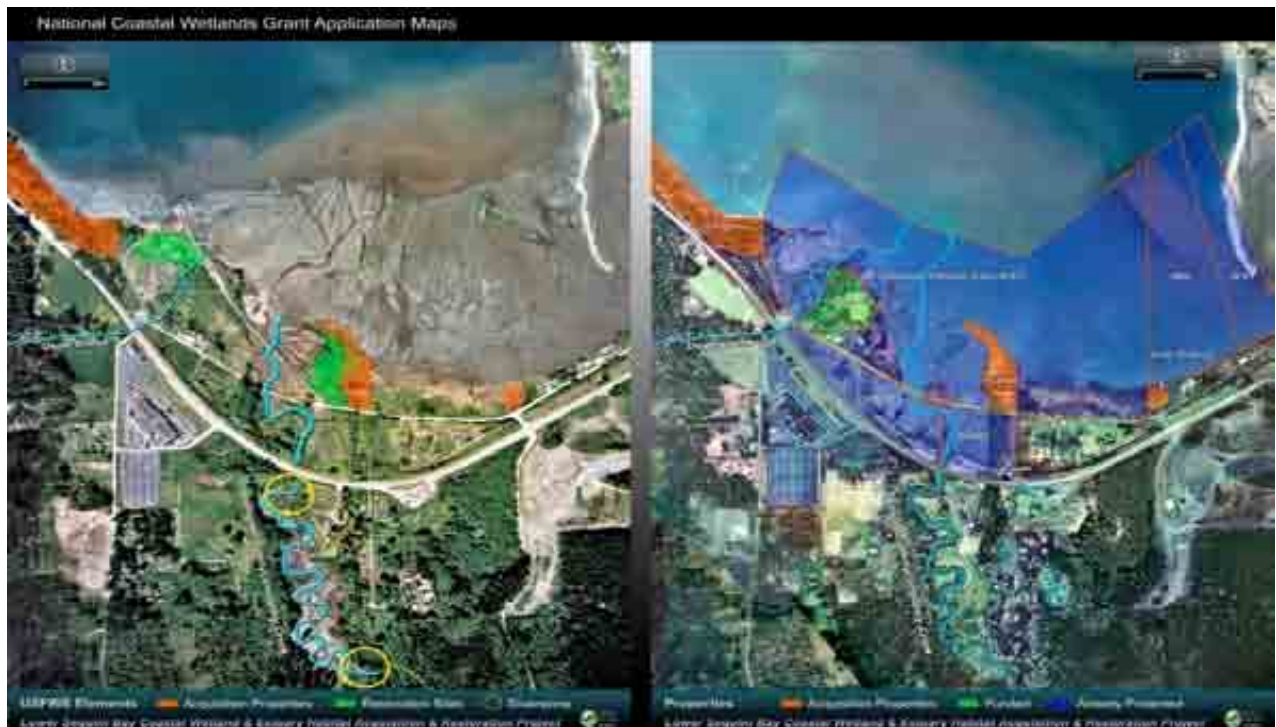
Color orthophoto with graphic overlay and alterations (Randy Johnson)

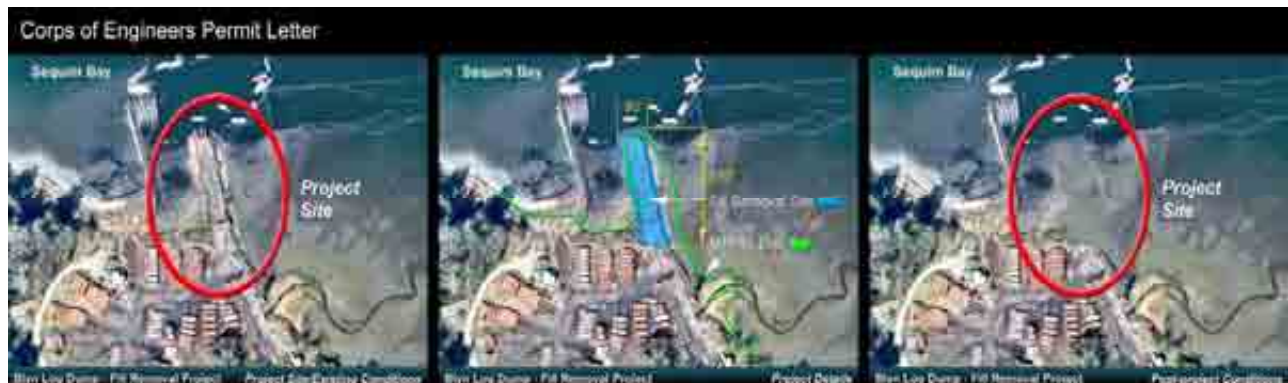
Color orthophoto with graphic overlay used for grant application (Randy Johnson)

A good set of pre-project color orthophotos (aerial photos taken perpendicular to the Earth's surface) of the restoration site is crucial. These will likely be the most useful photos for depicting current conditions, project elements, and proposed restoration conditions. It is also extremely useful to have photo sets taken annually during the life of the project, and preferably for several years post-project.

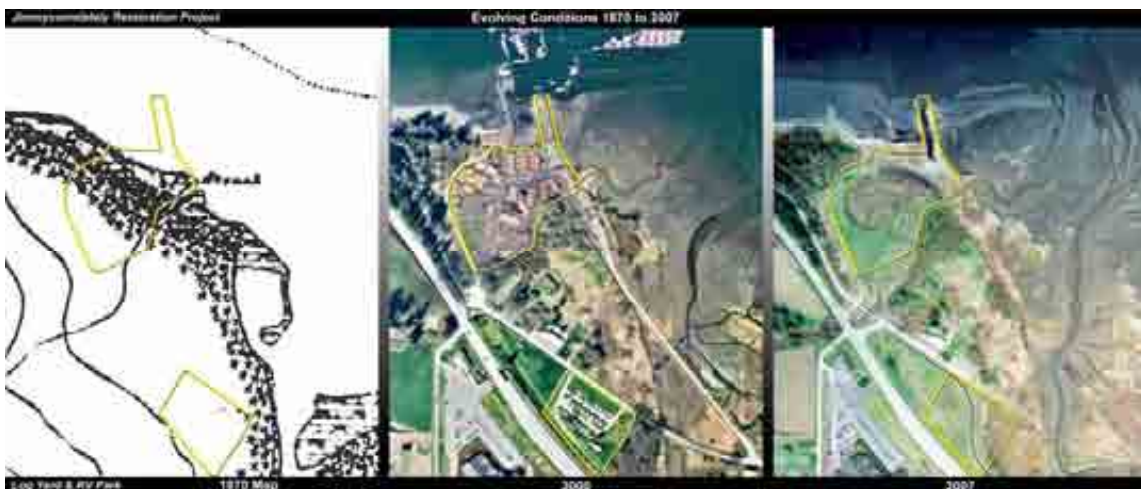
Historical map and aerial photo with graphic overlay (Randy Johnson)

Often human impacts pre-date the earliest photos of the restoration site. Therefore, maps usually provide the best information for understanding pre-disturbance conditions. When projects seek to restore ecosystem processes, as at Jimmy, pre-disturbance site conditions likely represent the best reference conditions for planning. In these cases, historical maps can be invaluable.

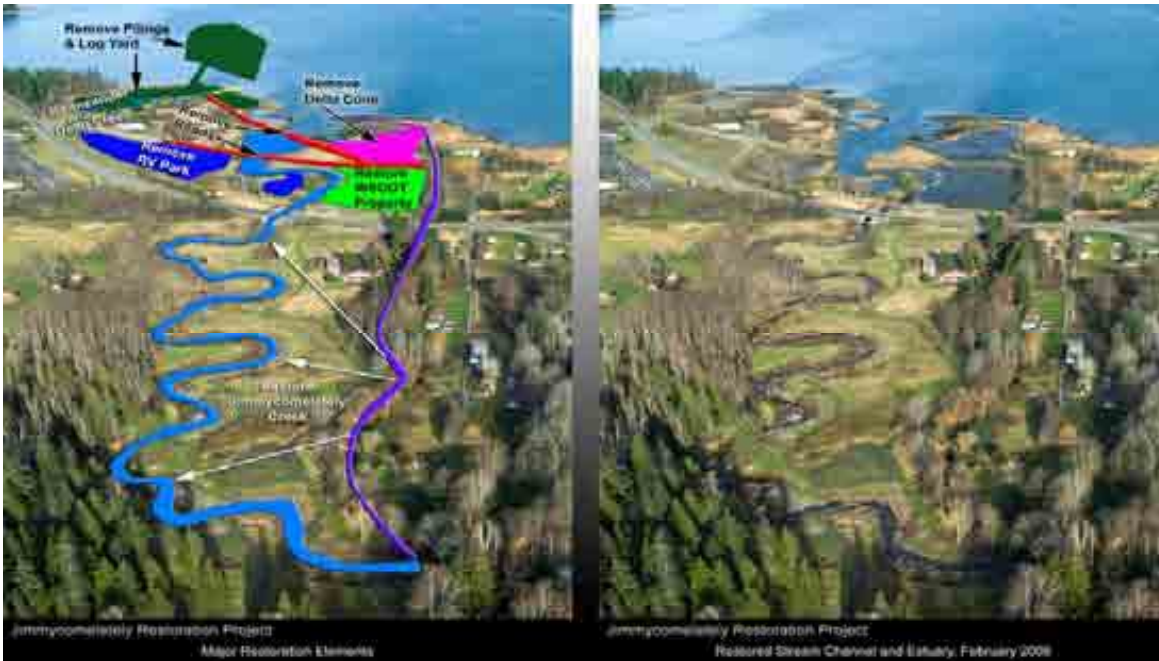
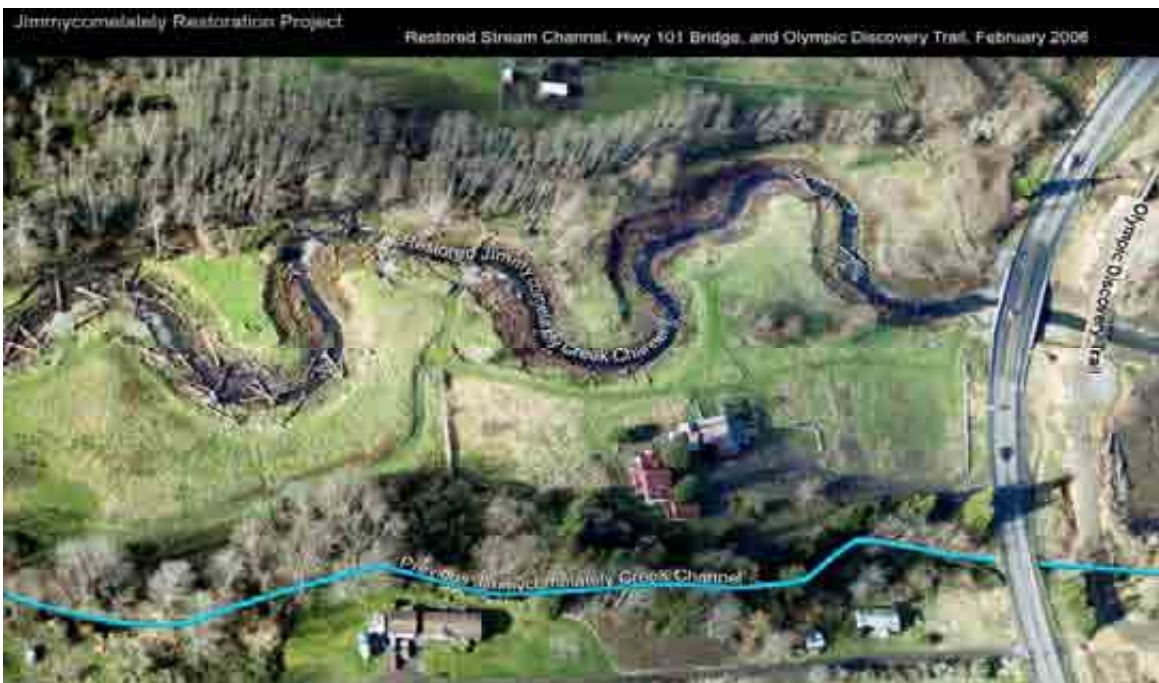
Aerial photo with graphic overlay (photo: David Woodcock, Greywolf Photography; graphic: Randy Johnson)

Although oblique photos are not useful for measuring or using in a GIS application, they do combine the realism of ground-level photos with the expansive view of orthophotos.

This quality makes oblique photos excellent for depicting the restoration site. Adding labels, lines, and other graphical features increases the information content of the photo enormously.

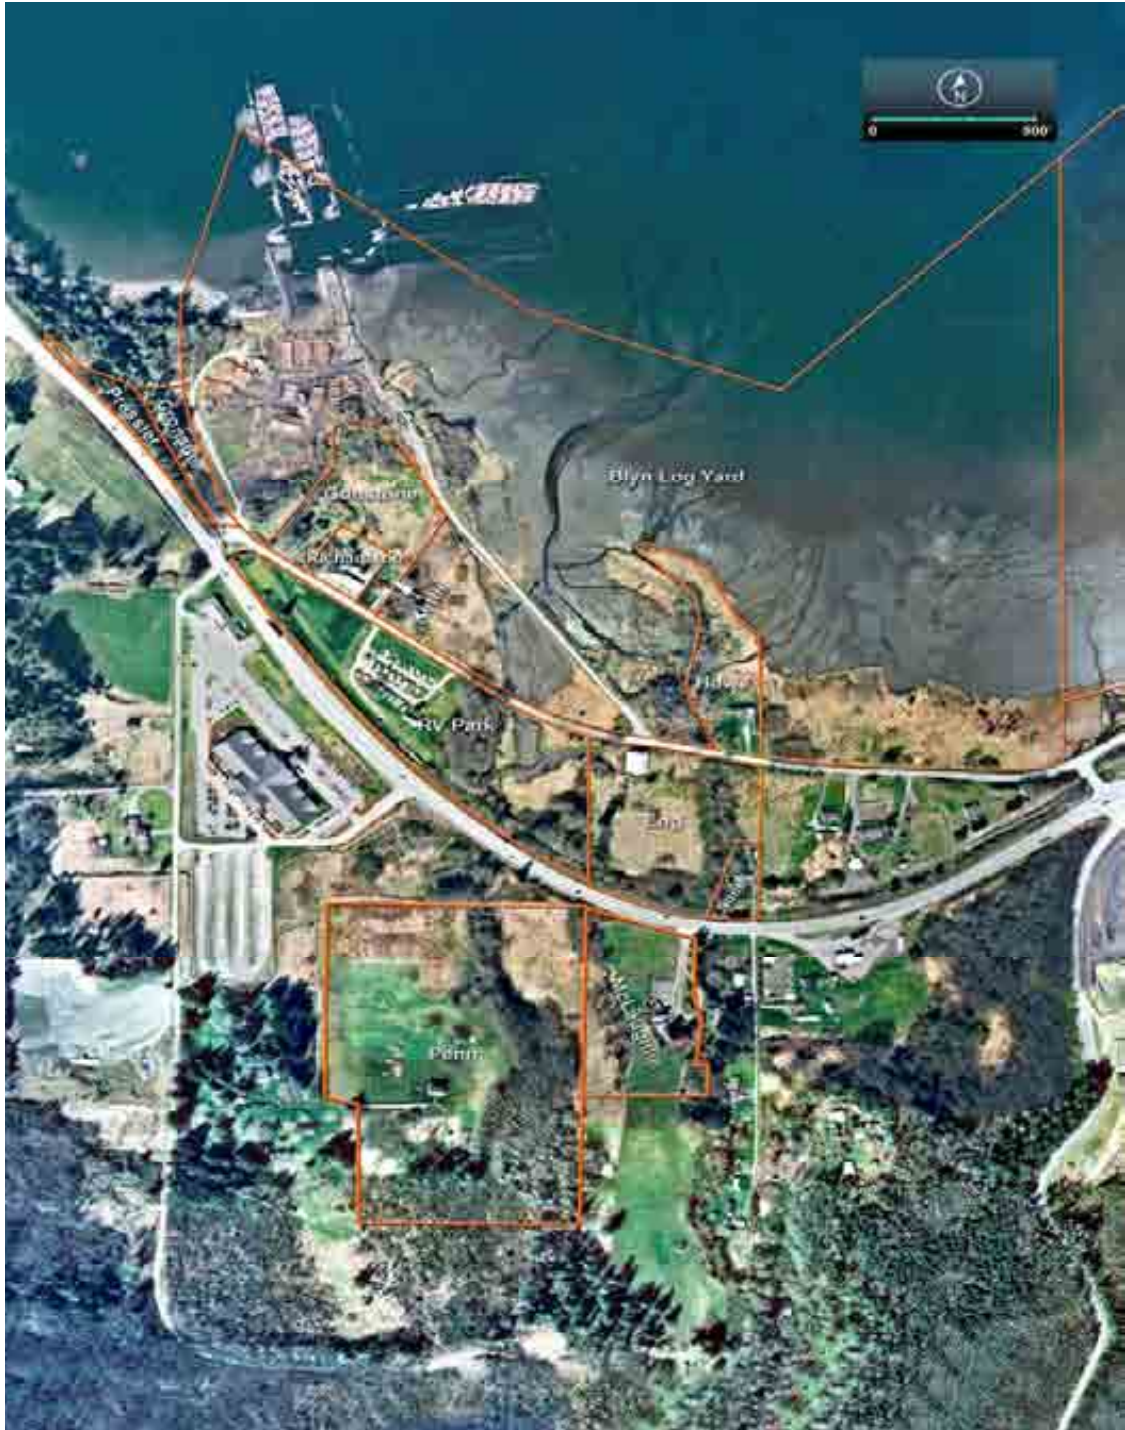
Properties involved in making the Jimmy Project possible (Randy Johnson)

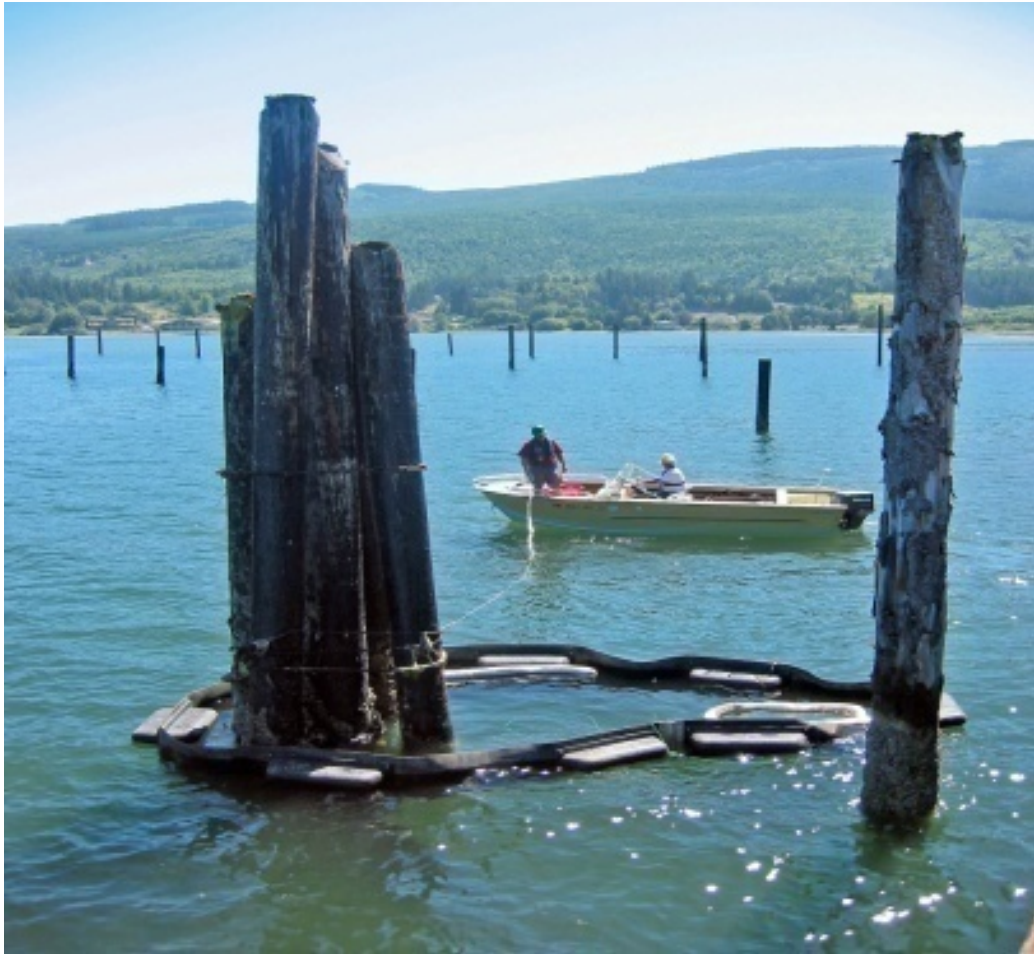
Water quality monitoring during the removal of creosote-treated pilings (Dave Shreffler)

- *Define pre-piling removal what degree of sediment plume is "acceptable" during removal.* Based on Optical Back Scatter (OBS) sensor data, the most significant sediment plumes resulted not from pulling the pilings but from the tug's prop wash while maneuvering the barge. The silt curtains did nothing to contain the sediment plumes caused by the tug's prop wash.

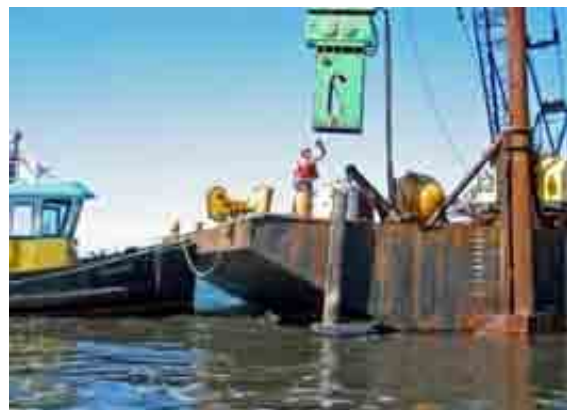
Creosote piling removal via vibratory hammer (Dave Shreffler)

In July and August 2005, a total of 99 creosote-treated pilings were removed from Sequim Bay via dead pull with a crane or via vibratory extraction from a barge-based operation (see photo below). Another 3 pilings were removed by

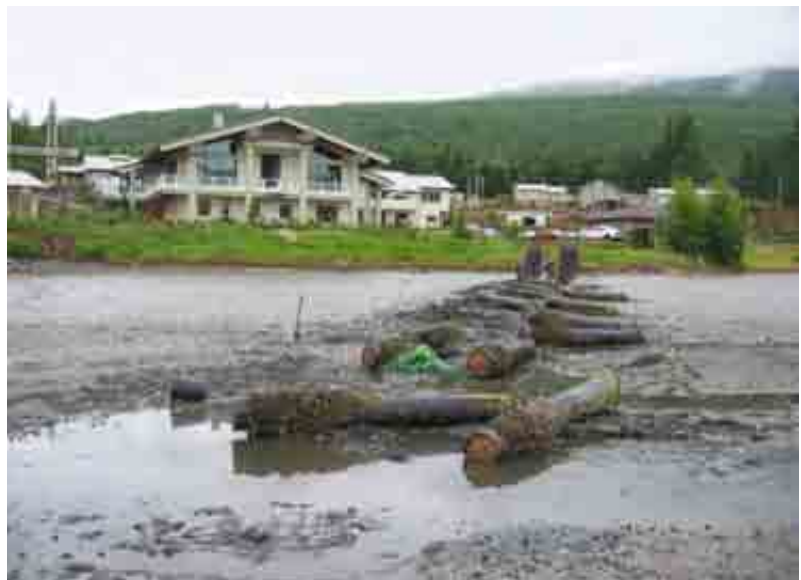
Pilings cut via chainsaw at low tide (Dave Shreffler)

- *Make sure your contractor understands the environmental as well as physical aspects of the project, is properly equipped and trained, and that lines of authority and communication are clear before work begins. On the Jimmy Project, the "time is money" mindset of the piling removal contractor was in direct opposition to the Tribe's "environmentally sensitive cleanup" mindset.*
- *Rigorously stick to all agreed upon best management practices (BMPs). Despite having BMPs clearly outlined in the contract, the environmental sensitivity of the piling*

- *Define pre-piling removal what degree of surface sheen is "acceptable" during removal.* The absorbent sausages were only an estimated 20-30% effective in cleaning up any observed surface sheen.

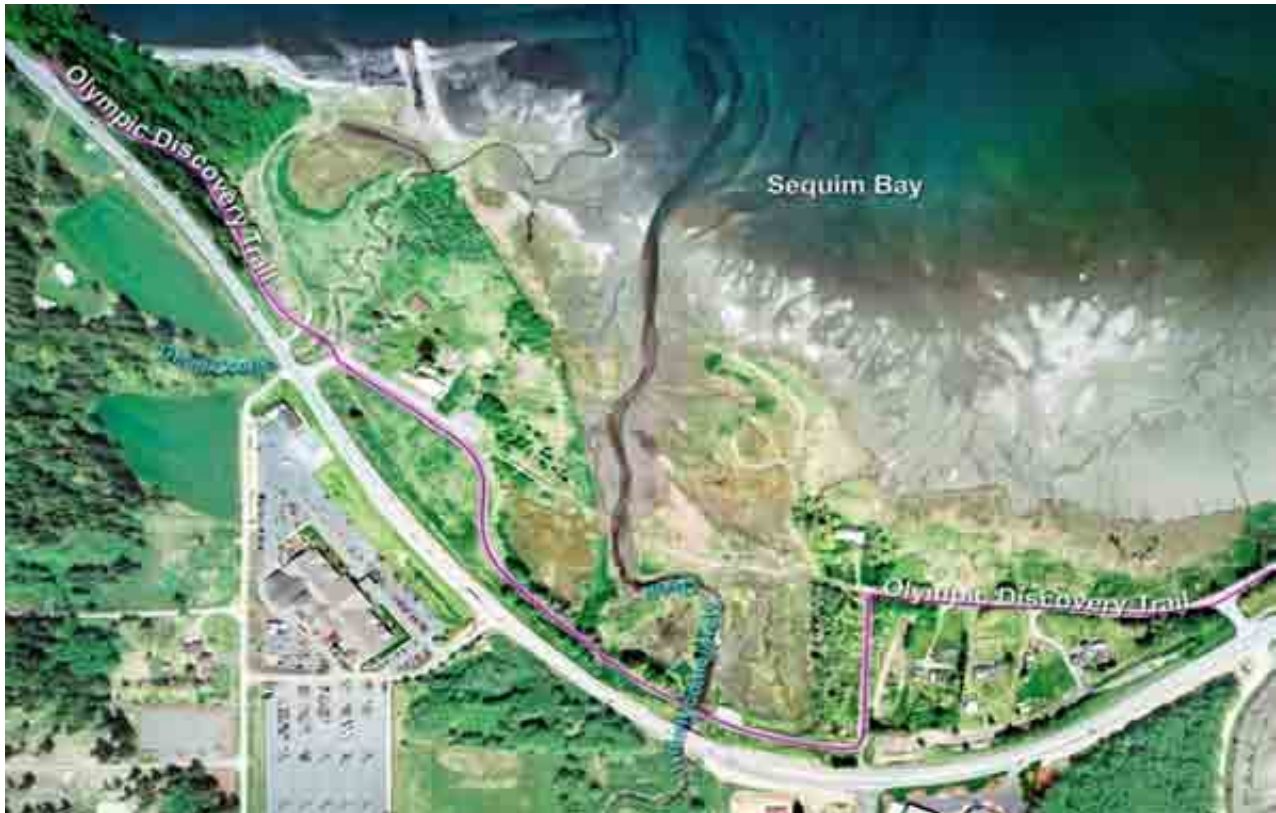
The Olympic Discovery Trail route through the Jimmy Project (Randy Johnson)

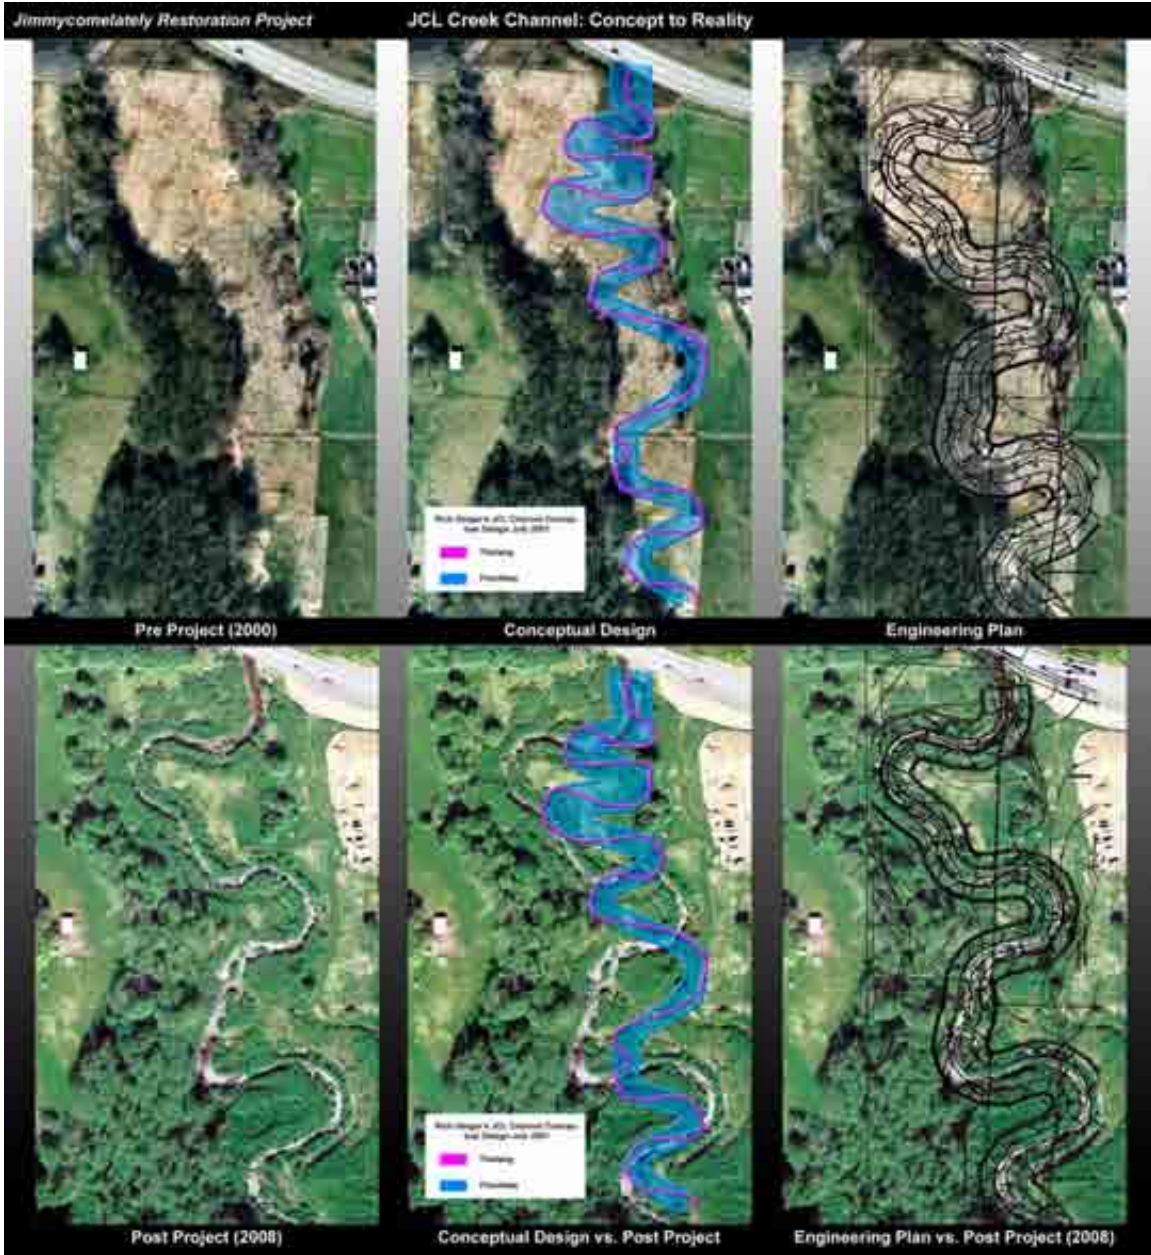
Jimmycomelately Creek Channel Design: Concept to Reality (Randy Johnson)

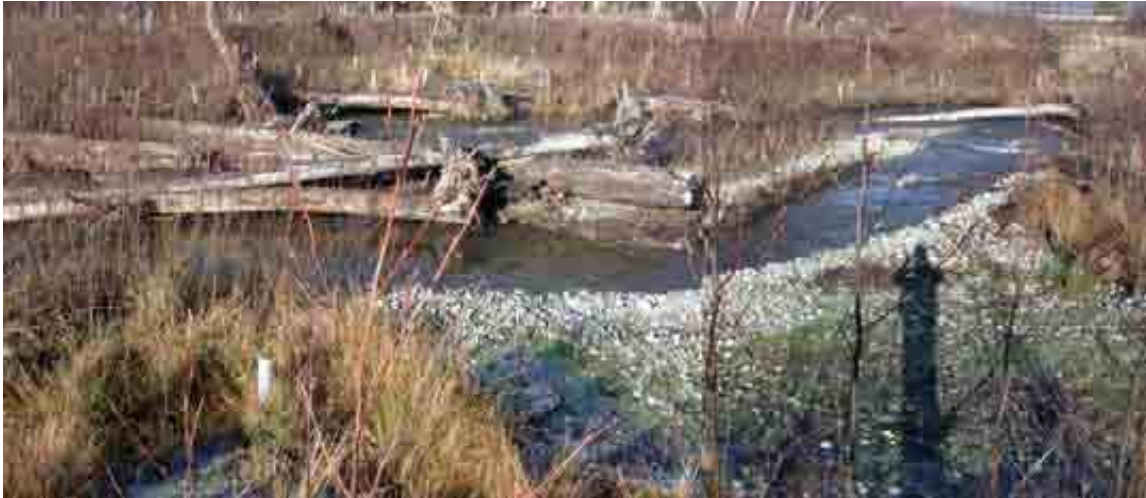
Jimmycomelately Creek during moderately high flow, December 28, 2006 (Byron Rot)
